Imported Fabricated Steelwork: Case Study #1

Glass barrier bridge truss

NSW Housing Estate Project Australia, 2012

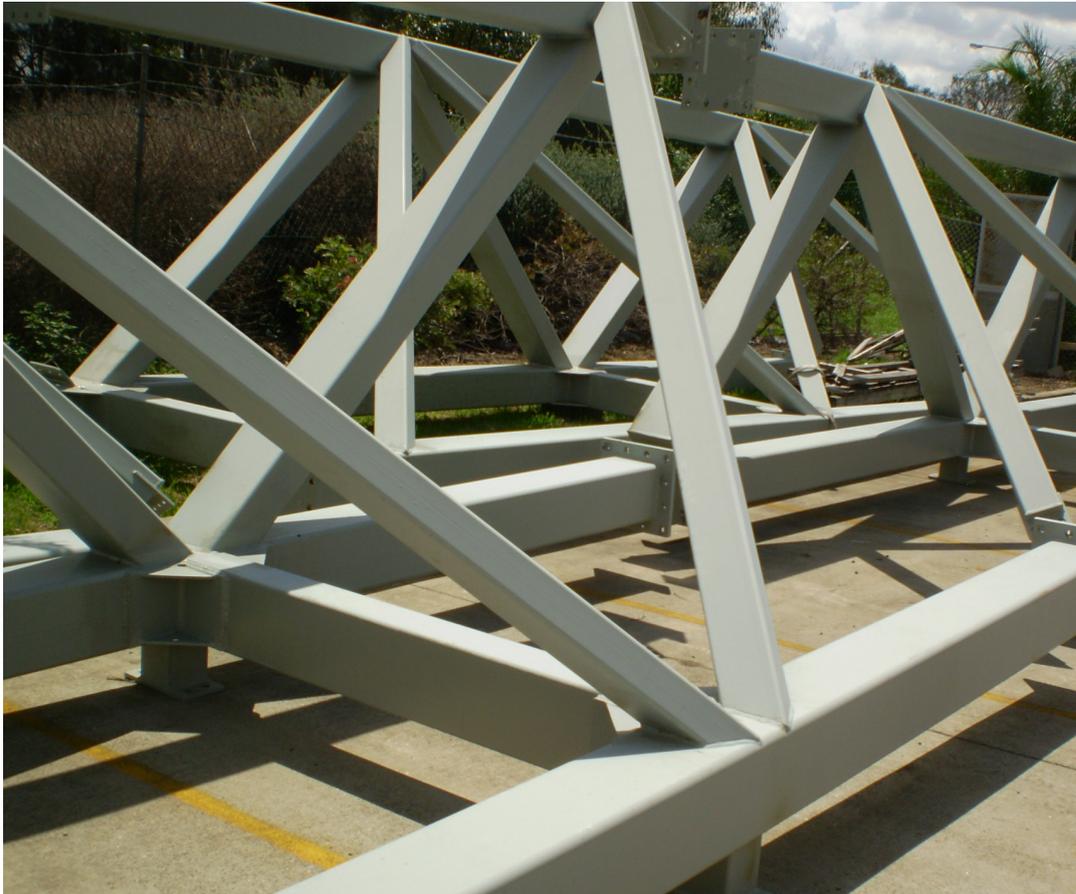
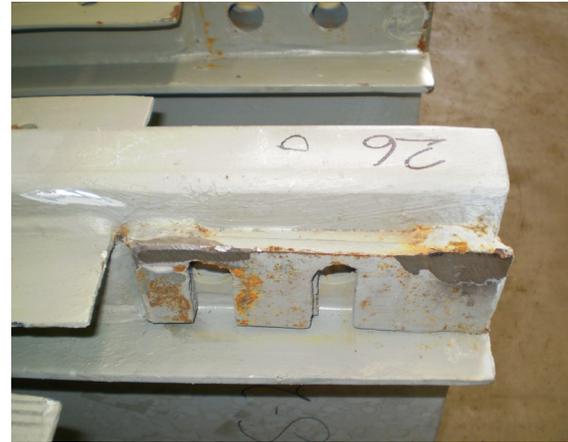
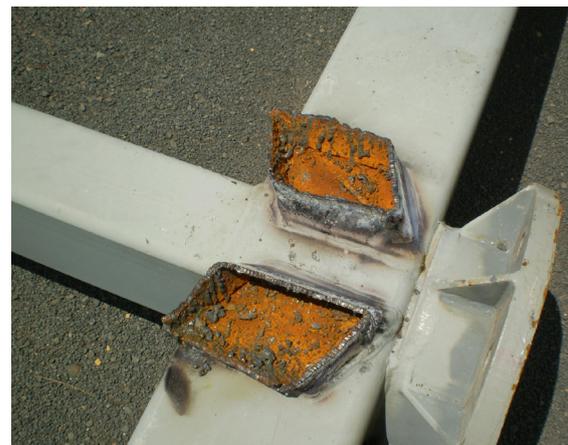
The first sign of problems with the truss was at installation: after its erection on site, the truss deflected. The builder attempted substantial on-site repairs, including reinforcing the areas where cracking occurred: in the junction between cross beams and main truss beams; and welding reinforcing tubing alongside sections of the cross beams that had split.

But the rectification work was insufficient to stabilise the structure. An Australian fabricator was engaged to rebuild the truss to largely the same design but with compliant materials and workmanship. The rectification and rebuild costs are estimated to be AU\$810,000 and, as the company responsible for importing the steelwork is now insolvent, were borne by the engineer's insurance company.

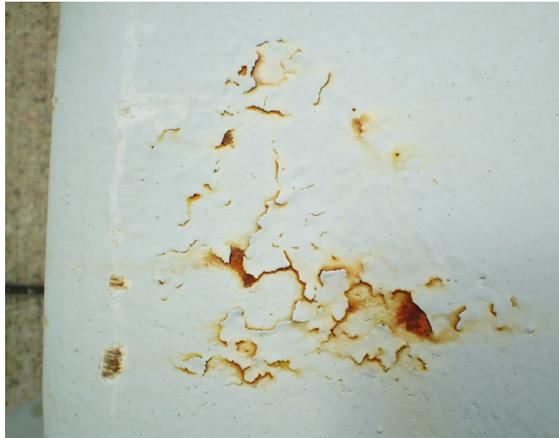
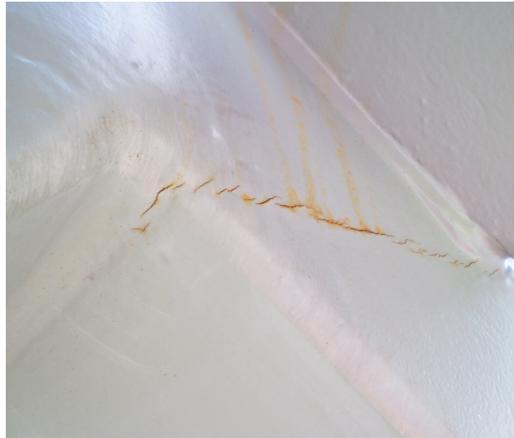
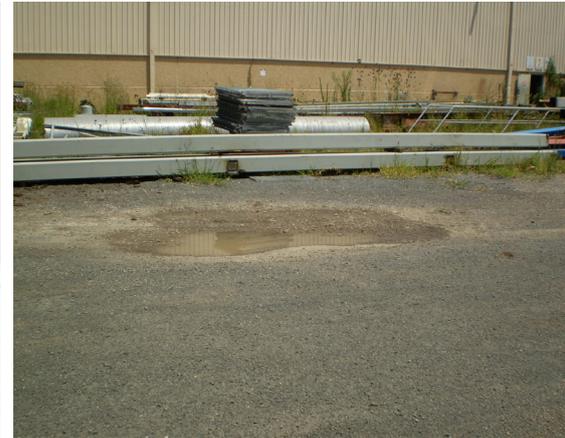
When the original imported steelwork was removed and taken to a local fabricator's yard for remedial work, several additional defects and instances of non-compliance were uncovered:

- Tensile testing showed the steel had a 338MPa yield strength versus a required 450MPa
- Connecting chords to beam were cut too short, requiring spacers to be inserted at each joint

- The diagonal chords, when cut, were found to be filled with water – possibly a deliberate ploy to increase the weight of the structure to achieve the specified weight

- Non-compliant elongated bolt holes drilled to allow fit, but created the risk of movement (30mm diameter holes for 20 mm bolts; 28mm diameter holes for 20mm bolts)

- The original paint system did not comply with the specified system
 - Poor paint finish against a specification of 75µm inorganic zinc silicate,
 - 125µm Epoxy and 75µm urethane

- Lacked the specified polyurethane finish
 - Variable dry film thickness with areas below the 20% tolerance level allowed by AS 3894.3
 - Inadequate film formation at edges of square hollow sections

- Welding was substandard and not compliant with AS/NZS 1554.1
 - Poor scarfing of the weld, including undercut with potential to be below the wall thickness specification.

- Fillet welds instead of full penetration butt welds
 - Use of a sleeve instead of the specified full penetration butt weld
 - Under cut on weld profiles
