NEW INSIGHTS INTO STEEL BUILDING PERFORMANCE FROM THE CHRISTCHURCH NATURAL LABORATORY

G. C. Clifton¹ and G. A. MacRae²

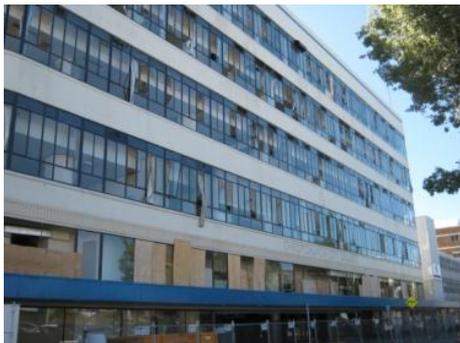
(a) Structural and claddings damage [J Ingham]

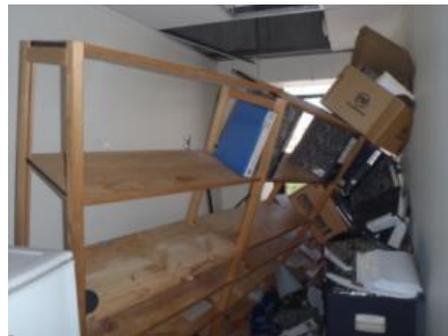
(b) Collapsed ceilings and contents [G Banks]

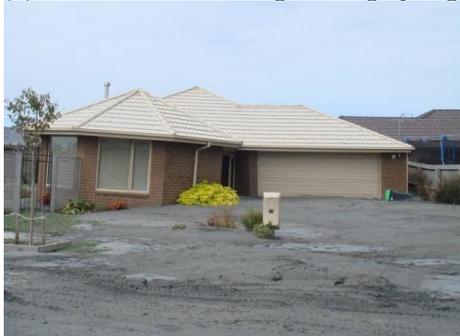
(c) Ground instability [M Pender]

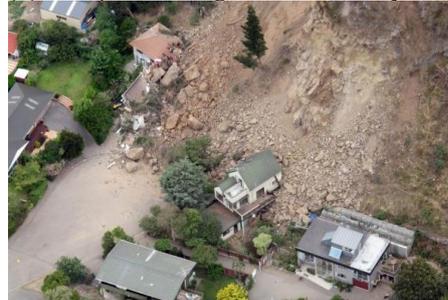
(d) Landslides /slope instability [M Pender]

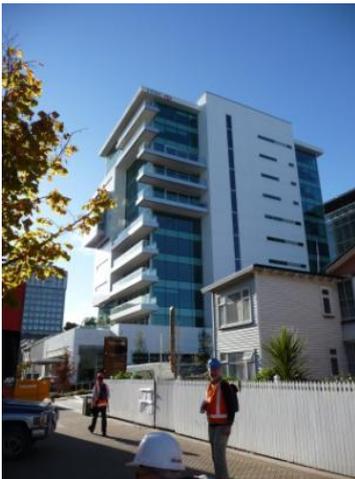
(a) Overall view of tower from North West Corner [M Bruneau]

in the active links with minor non-structural damage. An example is the 12 storey HSBC Tower, built in 2009, indicative photos of which are shown in Figure 2. This building self centered to a maximum residual drift of 0.14% following the 22 February 2011 earthquake and was returned to service in July, 2011.

Because the pattern of inelastic demand in this building was as predicted and the peak inelastic demand during the earthquake in the north-south direction (the direction parallel to the external concrete wall shown in Figure 2 (a)) could be determined by scuff marks on the stairs, the ratio of actual building stiffness to predicted building stiffness could be established with reasonable accuracy. The predicted interstorey drift under the design level event was 1.3%; the measured drift was $\approx 1\%$ under 22 February earthquake, which was $\approx 1.8\text{DLE}$ as averaged from the 4 closest strong ground motion recording stations. This gives a ratio of actual building stiffness to model stiffness of ≈ 2.3 .

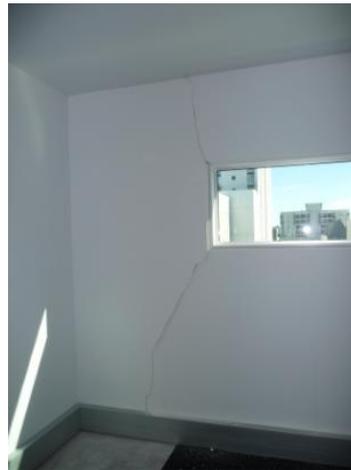
(b) Cracking to internal linings of a window-box [C Clifton]

PGV levels in the February 22nd 2011 earthquake exceeded 1g. This very high level had only minor influence on steel framed building; in HSBC Tower for example it enhanced non-structural internal wall lining cracking in cantilevered window boxes out the building's north face (see Figure 2 (a) and (b)) and dislodged opening glass doors from their supports (see Figure 4)

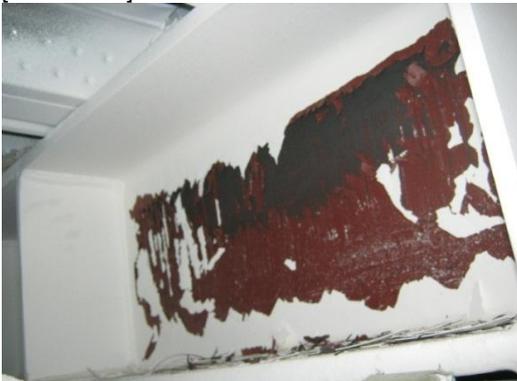
(c) Inelastic demand in EBF active link [C Clifton]

The peak plastic strain in the EBF active links was approx. 7%, in the 5th level link in the East-West direction,

shown in Figure 2 (c). This is less than 25% of the monotonic strain elongation capability of the steel.

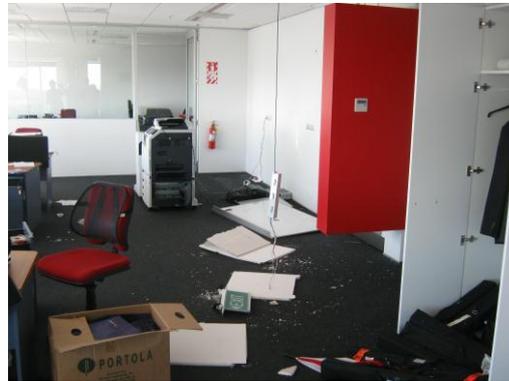
(d) Typical office following 22 Feb 2011 earthquake [C Clifton]

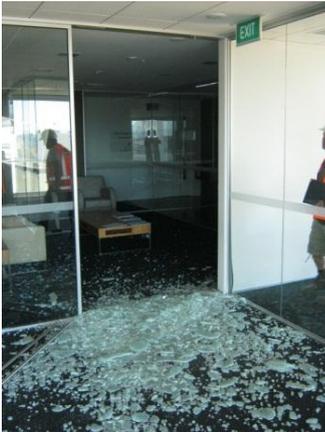
Figure 4 Dislodged glass door due to vertical acceleration [C Clifton]

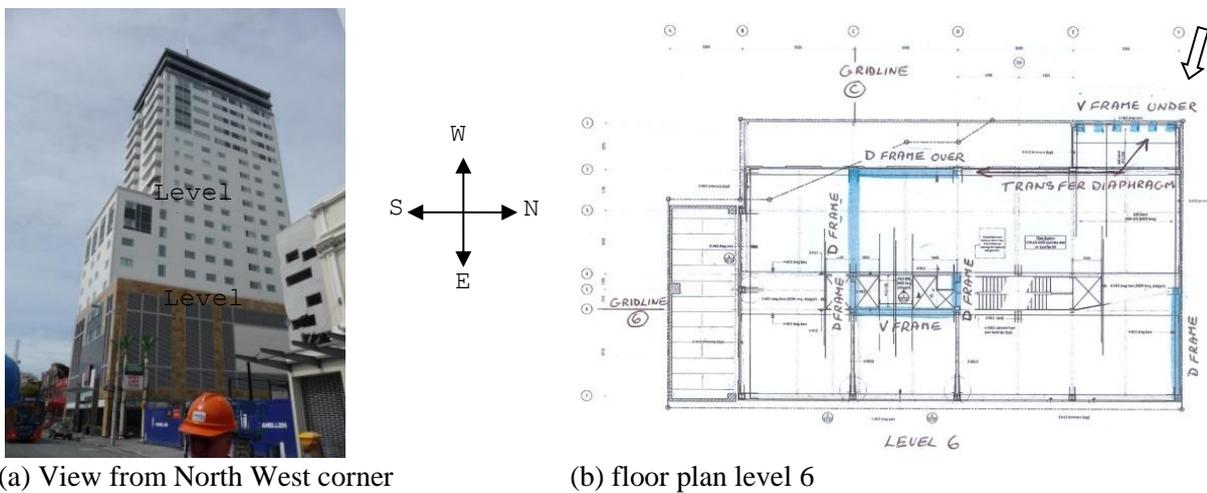
Figure 6 Pacific Tower [Photo by C Clifton, Floor Plans from S Gardiner] (the arrows in (b) show the direction of the view in (a))

Figure 6 shows details of Pacific Tower. In the North-South direction, there are only two EBF systems up the full height of the building. On level 6, shown in Figure 6(b), the V frame under the NW corner stops and the EBF transfers to the D frame for levels 7 to 22. The top link in the NW corner EBF fractured, either in the February 22nd 2011 earthquake or in the most intense earthquake of 13 June partly due to use of steel with less than the specified Charpy Impact energy. In principle, this broke the continuity of the seismic-resisting system on the west side of the building and should have generated high torsional actions especially around the 6th level. Evidence from non-structural linings cracking showed a very slight increase in inelastic demand in the 6th and 7th storeys, however this was minimal and there was no evidence of enhanced torsional movement. The floor slab functioned as an effective transfer diaphragm. This building is being repaired, scheduled for completion by March 2013.

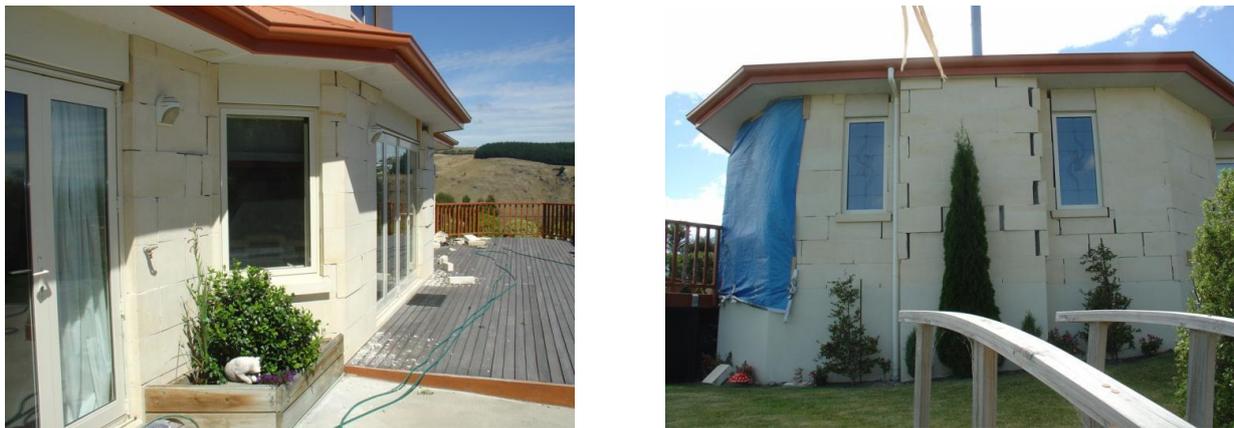
Figure 7 Two storey light steel frame house with Oamaru stone cladding [T Just]

Performance in the Christchurch earthquake series was consistent with this; no damage to minimal hairline cracking of plasterboard linings for houses on good ground. The most outstanding example of LSF performance was a two storey light steel framed house with Oamaru stone cladding, situated very close to the epicenter of the 22 February 2011 earthquake and to a strong motion station that recorded PGA_H and $PGA_V = 1.8g$ in that event (a higher PGA_V was recorded at another station, but that figure is suspect to falling material in the vicinity of the recorder). Figure 7 shows two views of this house, showing the movement of the Oamaru stone on its bedding planes. There was also minor cracking to some internal wall linings. Both were

readily repaired. With the Oamaru stone units being 4 times the weight of a standard clay brick and the acceleration demand being double that of the shaking table experiments, this was a much more severe test of the light steel framed house system and the most demanding example studied from Christchurch.
