An Innovative Approach to Wind Strengthening of a Cantilevered Stadium Roof, Yarrows Stadium, Taranaki

C. Twaddle and R. Van Bergen
Beca Ltd, New Zealand
Fitzroy Engineering Group Limited
New Plymouth District Council

ABSTRACT: This case study outlines the assessment and innovative retrofit of a large cantilevered stadium roof at Yarrows Stadium, New Plymouth, Taranaki that sustained significant wind related damage in a high wind event in 2012. The stadium roof sustained damage to a significant area of roofing due to a roof fixing failure. However the investigation highlighted a significant change in the wind loading standard associated with cantilevered roofs. Through agreement with the then owner, the New Plymouth District Council (NPDC), a roof structure review by Beca was initiated.

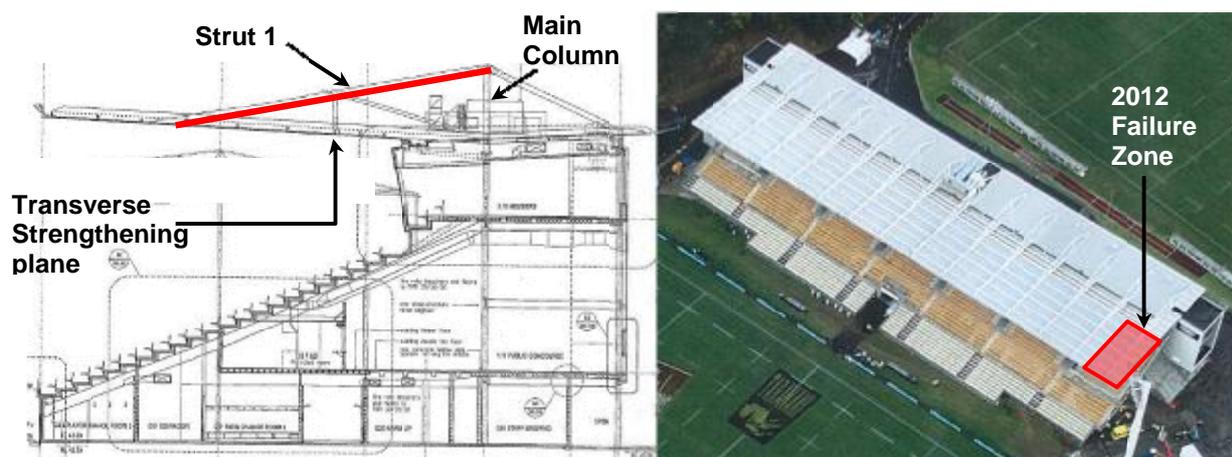
Figure 2 & 3 – TSB Stand Typical Section and Perspective View

In March 2012, the TSB Stand suffered high wind related damage from a gust event(s) from the south west which loaded the underslung roof such that it caused the roofing to puncture through the fixings that held the roofing to the underside of the RHS purlins.

The damage occurred on the SW tip of the TSB Stand and covered an area of 90 to 120m². Refer to Figure 3 above for an annotation of the failure area.

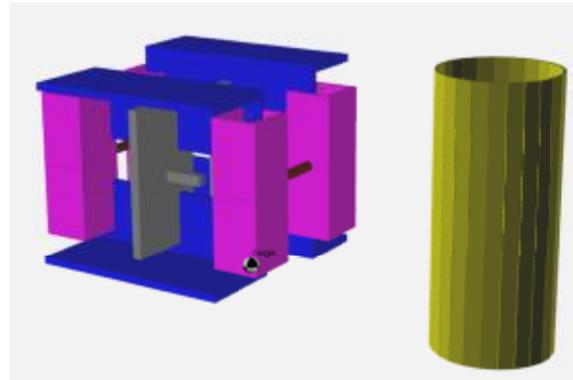
Figure 7 – Space Gass Clamp Model

as the existing structure, calculations were conducted by hand then verified by the use of a Space Gass model of the clamp (refer to Figure 7). The findings of this exercise raised the following:

- That the clamping load as well as action on the existing 163CHS vertical strut was acceptable even in consideration of the existing loads in the CHS from uplift actions.

- That the loading distribution the clamp was very sensitive to its support conditions (ie the rubber sleeve and clamp stiffness).
- That the clamp bolting to the existing strut had to be minimized closely to the design actions as when TF bolting is torqued to minimum tension and the clamp has room to deform, then the clamps take on significant load.

- To address even minor loading the clamps needed to be significantly stiffened in the detailed design, thereby taking the single clamp half weight to 28kg, and the double clamp half weight to 50kg. Installation methodology became topical due to difficulty manhandling of these weights.
