PERFORMANCE, DAMAGE ASSESSMENT AND REPAIR OF A MULTISTOREY ECCENTRICALLY BRACED FRAMED BUILDING FOLLOWING THE CHRISTCHURCH EARTHQUAKE SERIES

This paper presents a summary of the performance, damage assessment and repair of a multi-storey Eccentrically Braced Frame (EBF) building following the Christchurch earthquake series of 2010/2011. It describes the damage observed and the methods used in the post-earthquake evaluation of the building. It includes a description and the results of non-destructive processes used for the determination of active link plastic demand and the subsequent recommendations for leaving links in place or replacement. It presents probable reasons as to why one of the active links fractured and provides some recommendations for future EBF detailing, both to increase toughness and for ease of replacement. The paper also covers practical considerations relating to the repair and replacement of damaged active links in existing EBF systems in which replacement requires cutting out and fitting of new links. The paper is an update to one of the same title presented at the SESOC Conference in November 2012.

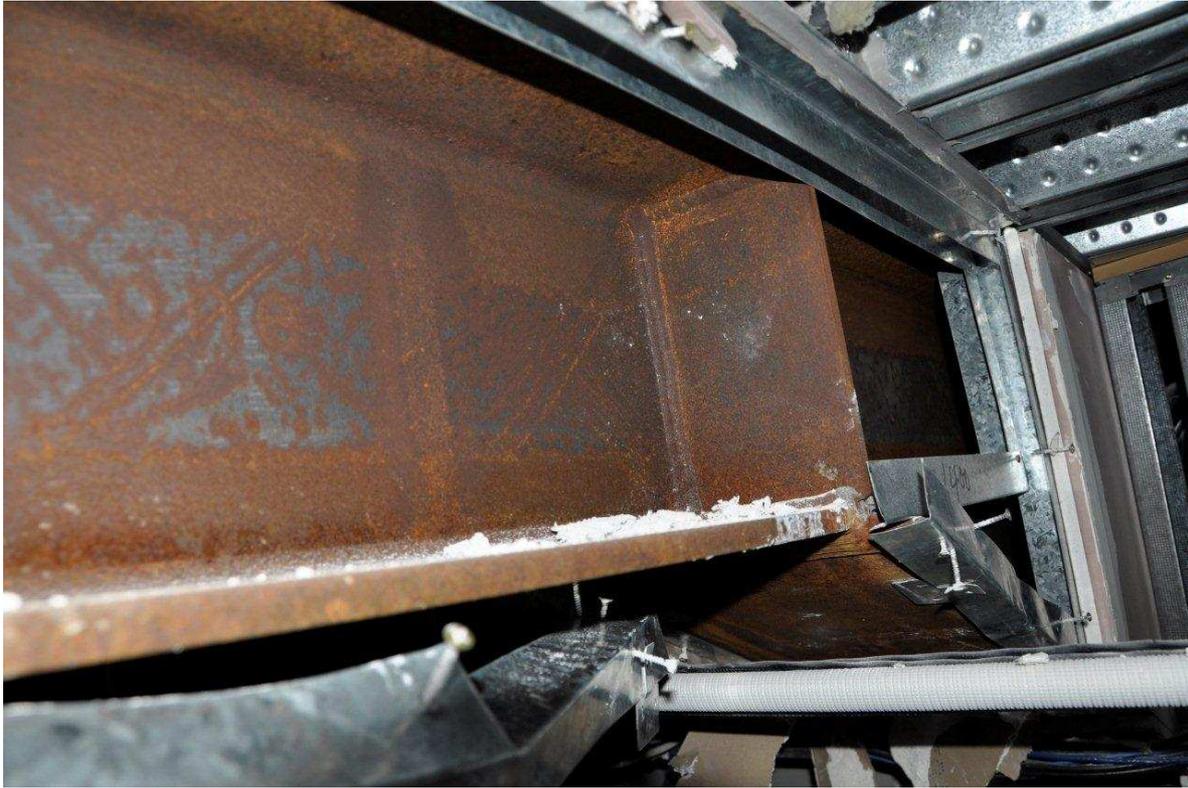
Initial inspections of a sample of active links after the September 2010 and February 2012 earthquakes, revealed minor permanent offsets in those regions and the onset of shear yielding as evidenced by the appearance of diagonal Luders lines, as shown in Figure 1, and paint flaking in the web regions. Initial conclusions were the links had been subjected to a few cycles of demand in the inelastic range, but that the steel would likely have retained sufficient ability to absorb damage to withstand, at least, another Ultimate Limit State (ULS) earthquake.

Figure 1: Active link with diagonal Luders lines. Image Spiire New Zealand Ltd.

Note that Figures 1 to 3 all indicate a lack of seismic induced plastic strain penetration into the top and bottom 20% of the web. Preliminary indications are that this may be due to prestraining of these regions of hot rolled sections by the manufacturing process.

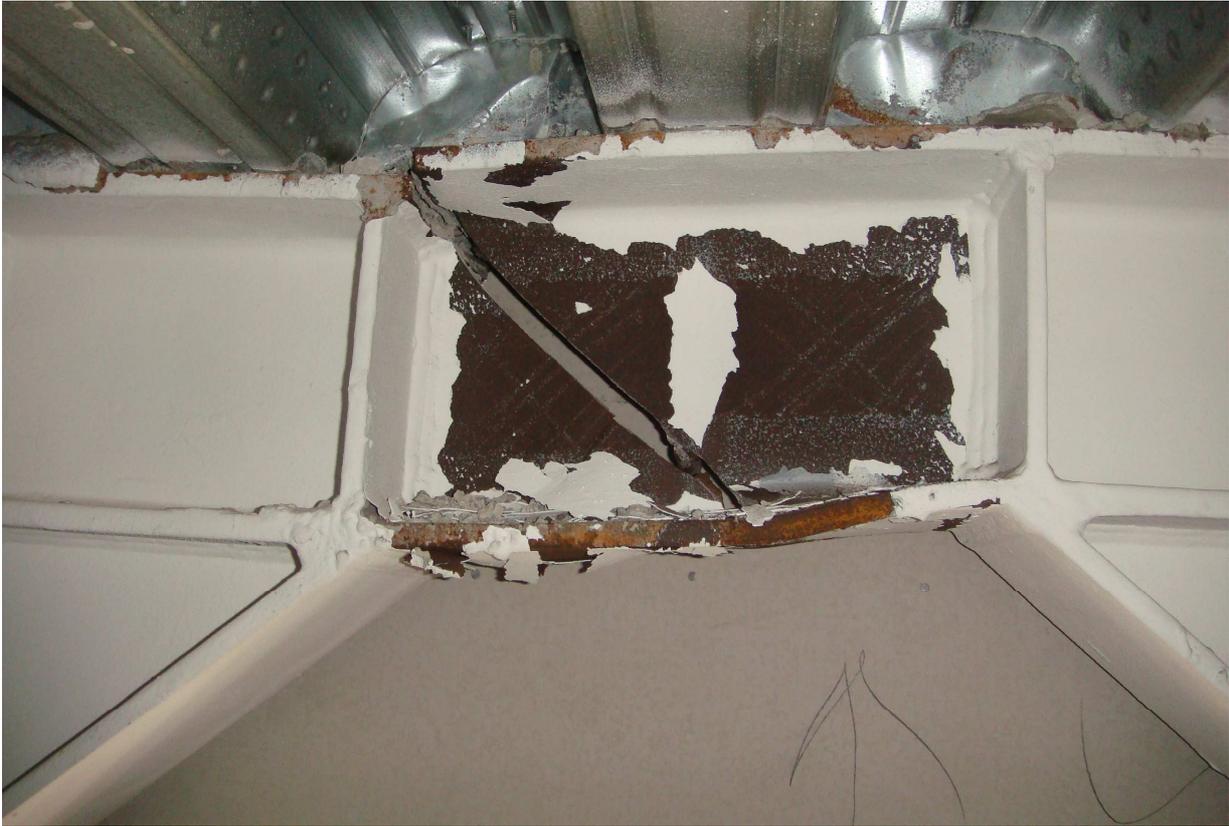
In August 2011, 5 months after the most significant shaking event, during inspections of the carstacker restraints, a fractured link was discovered at the north-western corner of the building at the underside of Level 6 (top of the western podium and carstacker levels) as shown in Figures 2 and 3. It is suspected the fracture occurred as a result of the June 2011 earthquake, given the evidence of several cycles of inelastic demand, and the cooler temperatures during that event, however it could have occurred in the February earthquake during load reversal. This led to the detailed inspections of all 126 active links, but revealed no further fractures. As a result of this, it is recommended all active links of EBF buildings be inspected following earthquakes where any inelastic demand is evident. Inspection hatches should ideally be placed to allow quick and clean visual inspection, and access for further testing if necessary.

Figure 2: Fractured active link. Image Spiire New Zealand Ltd.

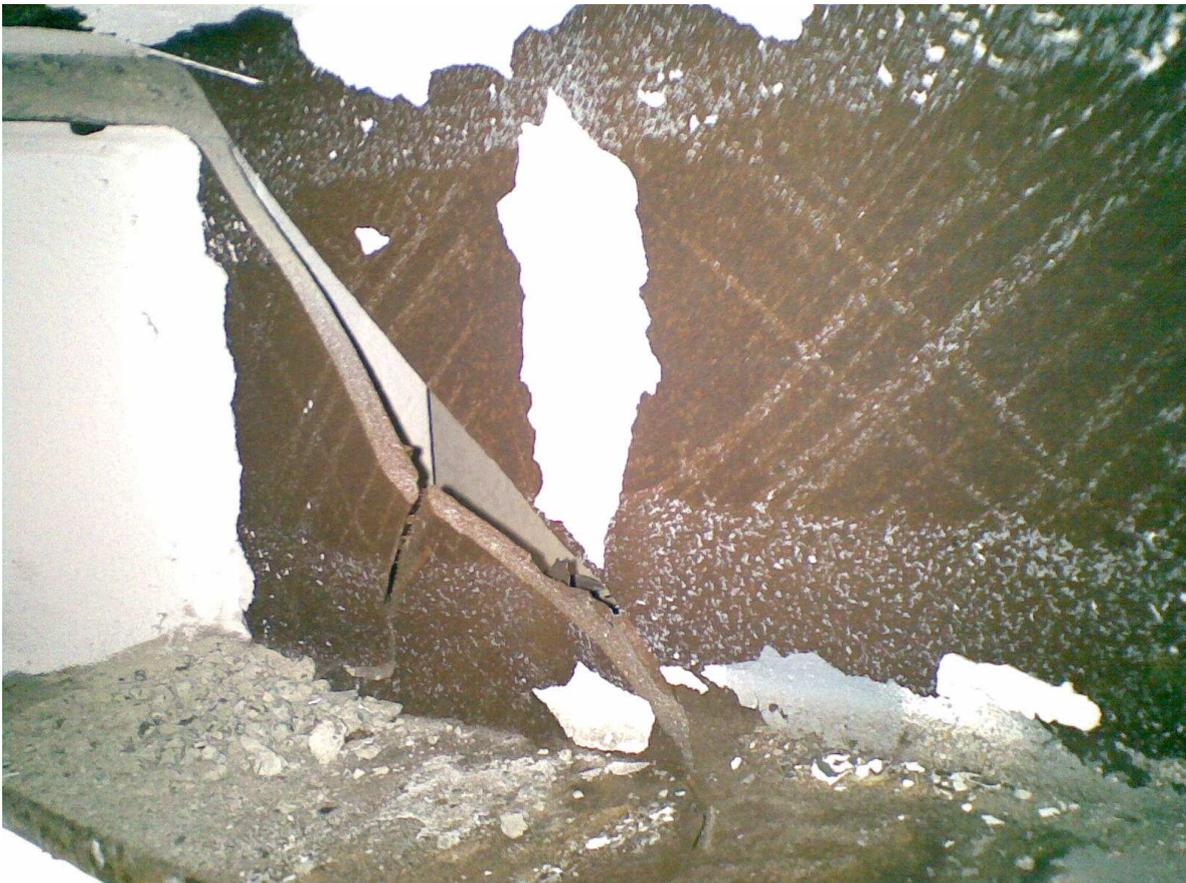
Figure 3: Fractured active link. Image Spiire New Zealand Ltd.

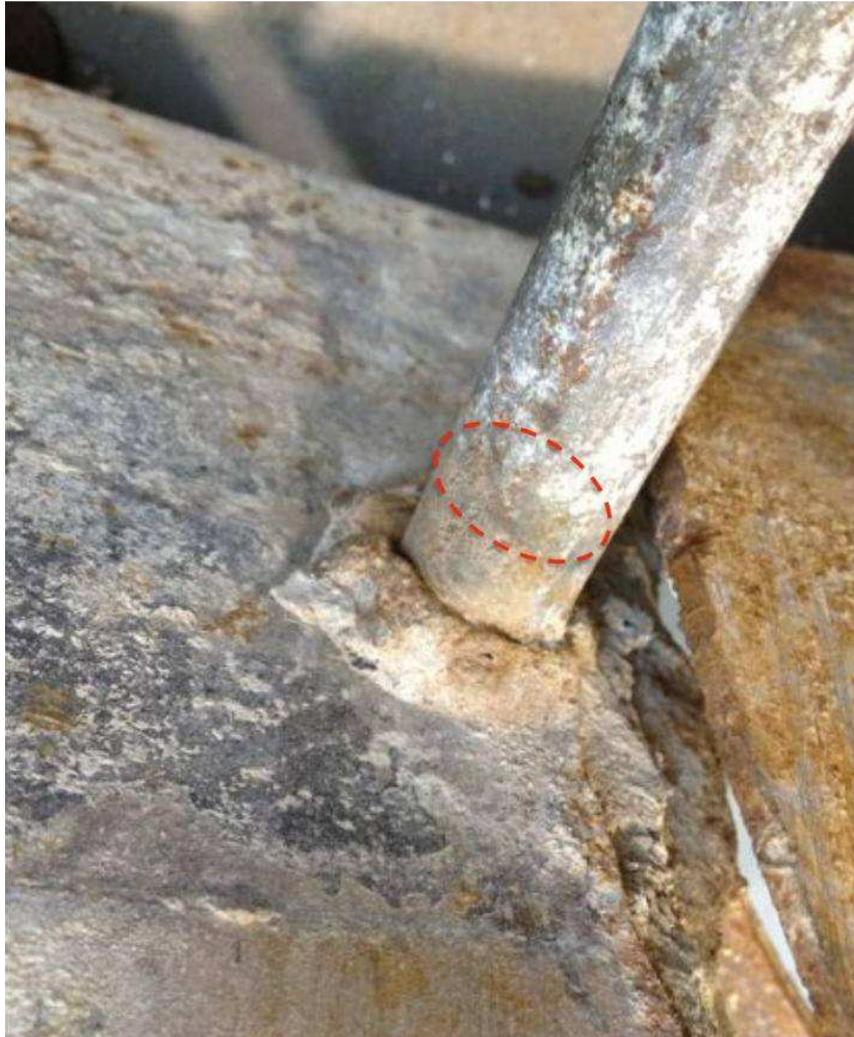
In summary, the likely reasons behind the fracture identified were:

- Low fracture toughness (low Charpy Impact values).

- The location of a shear stud(s) above the brace web stiffeners forming the active link was a potential fracture initiation site.
- Shorter link length imposing higher hinge rotations in this frame compared to the others in the building.
- The colder temperatures associated with the likely time of the fracture, in the two strong earthquakes of 13 June 2011, with much colder air temperatures compared with the first damaging earthquake event of 22 February 2011.

Figure 4: Link fracture adjacent to shear stud. Image courtesy Milo Kral, University of Canterbury

Interim recommendations are that checks be put in place to ensure that only steels complying with the current provisions of NZS3404 [2], for example Grade S0, are used in the fabrication of EBFs. Shear studs located above or near active link regions should be located no closer than above half way across the panel zone adjacent to the active link and we recommend it be located above the panel zone stiffener on the panel zone side remote from the active link. It is also recommended links of similar length be used for frames acting in the same direction, so that imposed plastic rotation demands are similar.

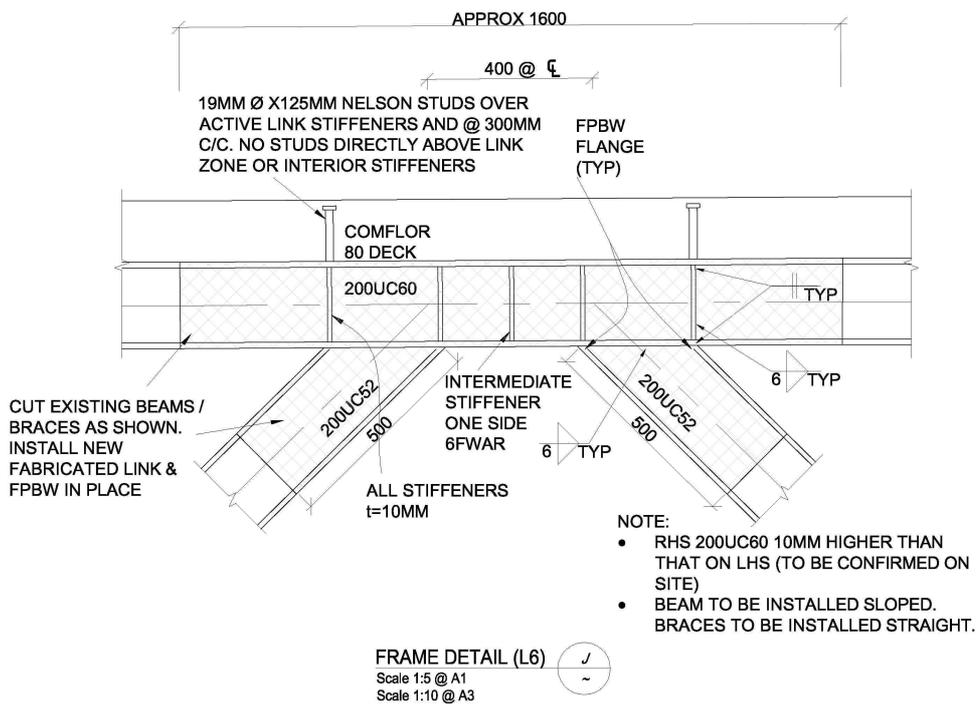
Figure 5: Replaced active link detail. Spiire New Zealand Ltd.

The first four active links in the north-west frame were replaced by removing the complete active link, adjacent panel zones and approximately 300mm stubs into the collector beam and braces. A template was created and a new link fabricated and then four full section butt welds were required on site to complete reinstatement. Bolted-in active links were considered but would have required extended endplates (bolts above and below the flanges) and were discounted as most of the links were not connected to a floor slab (adjacent to a car-stacker), and relied on a heavy beam of top of the link to provide lateral restraint, which would have clashed with the endplates. To allow all of the links to be removed and replaced at the same time, temporary Reidbrace cross-braces were installed to reinstate capacity to the frame line, and provide some ability to straighten the column elements.

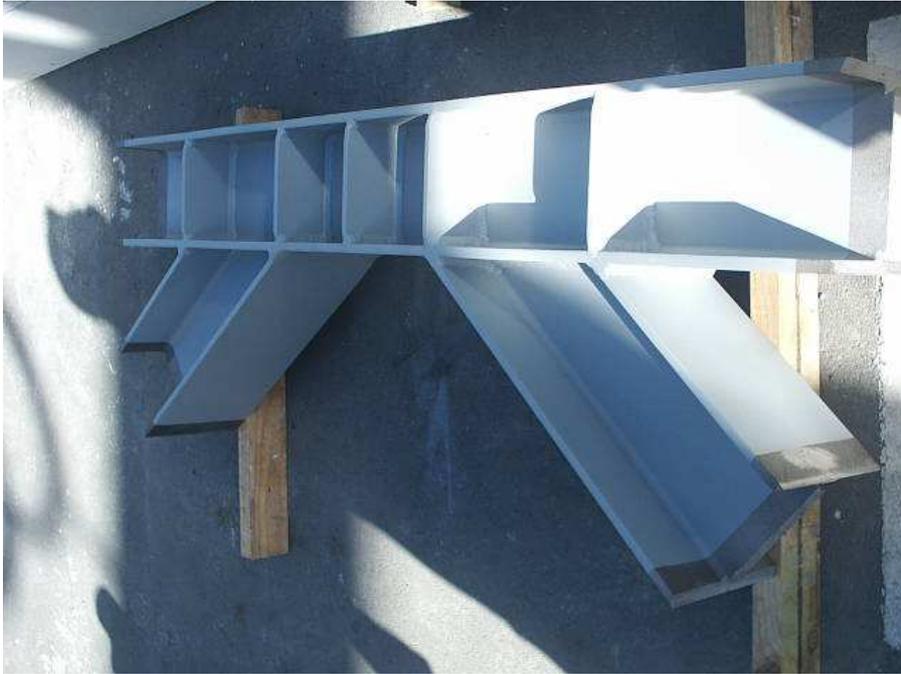
Figure 6: New active link prior to installation on site. Image courtesy of Fortis Construction.

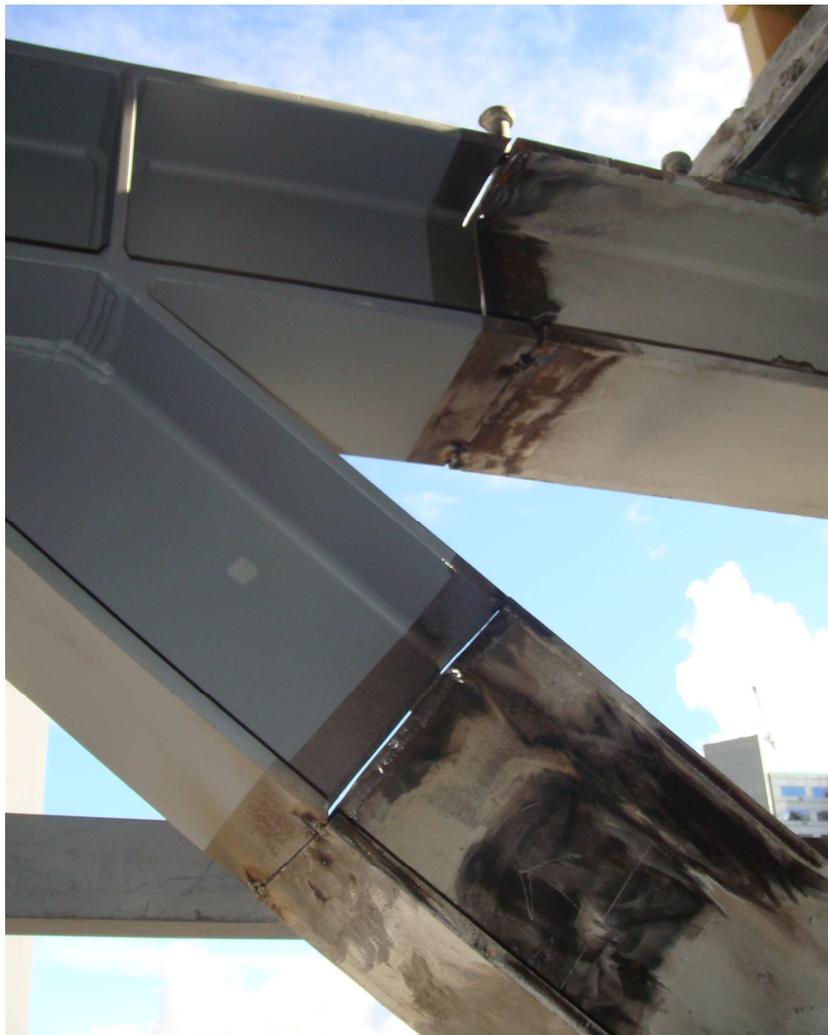
Figure 7: Active link replacement location prior to welding. Image courtesy of Fortis Construction.

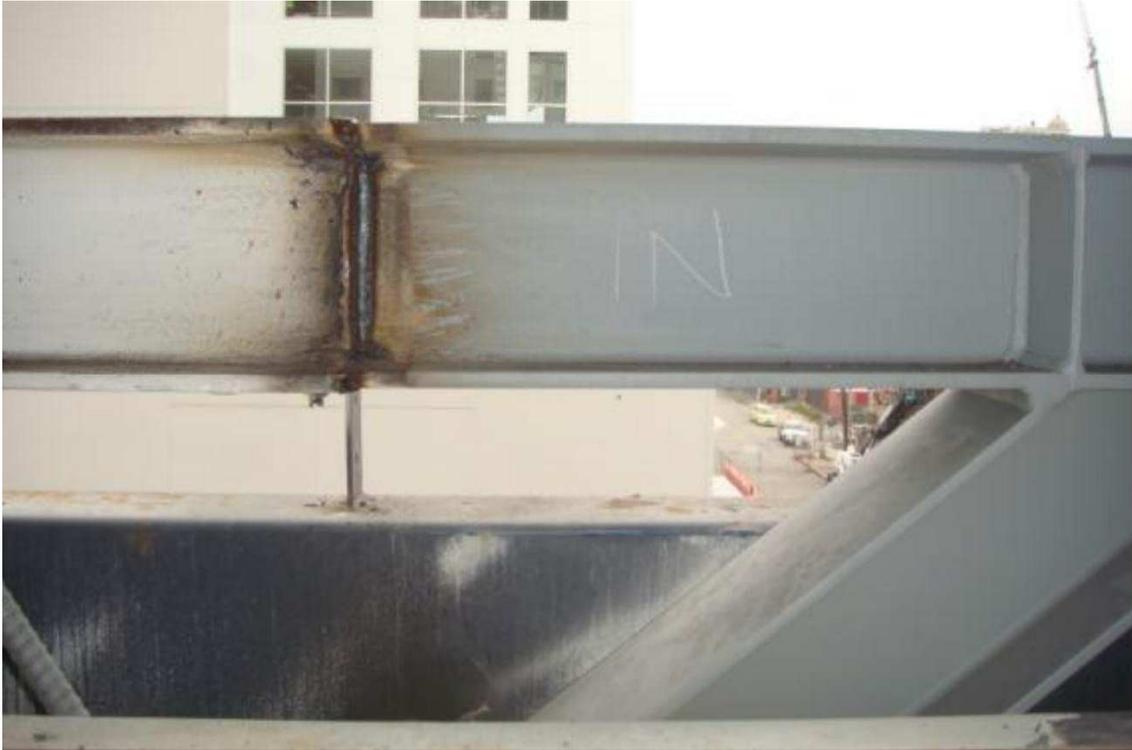
Figure 8: Replaced active link welded in place. Image courtesy of Fortis Construction.

Fabrication was complicated by a slight residual vertical offset across the collector beam ends. The new links were installed slightly off horizontal to accommodate the difference, in preference to prestressing the collector beam ends to align perfectly horizontal.

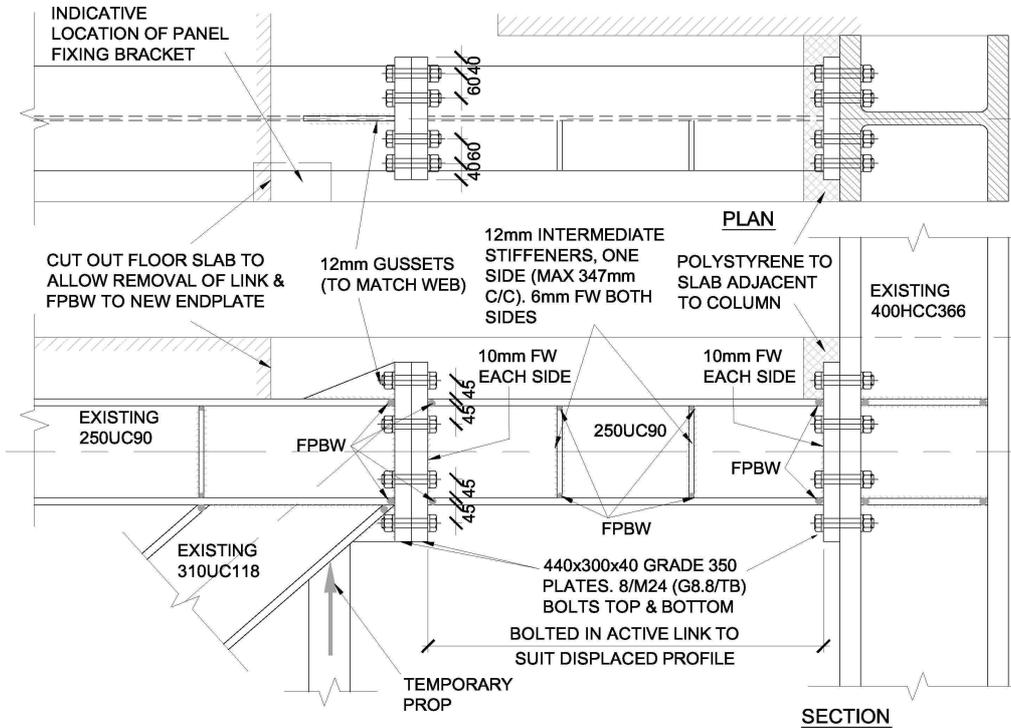
Figure 9: Bolted-in active link detail. Image Spiire New Zealand Ltd.

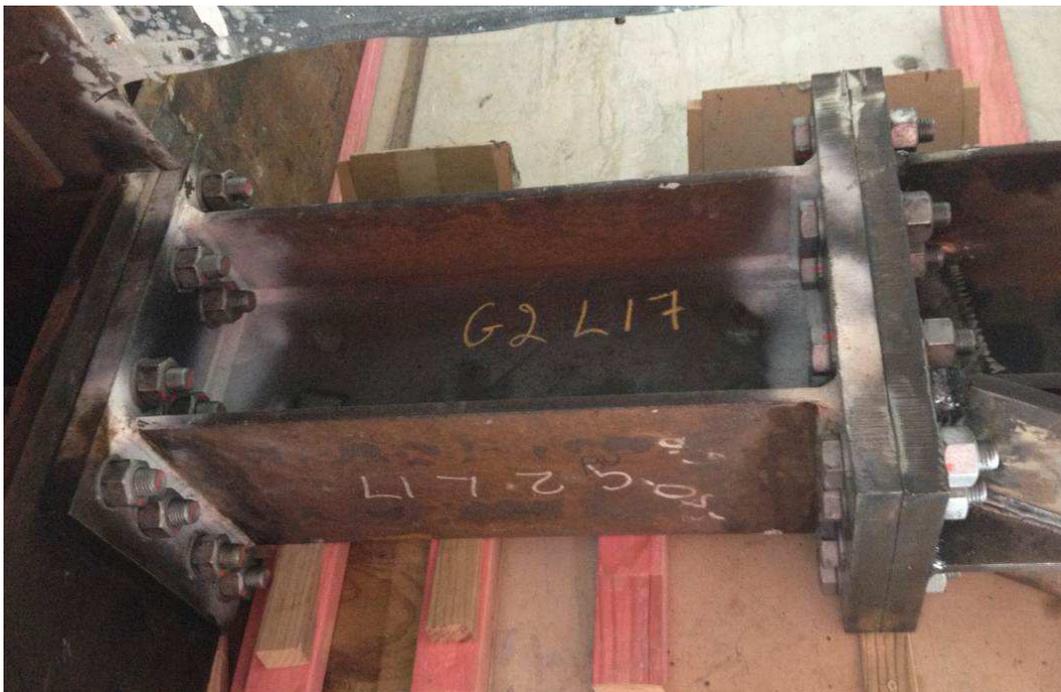
Figure 10: Bolted-in active link. Image Spiire New Zealand Ltd.

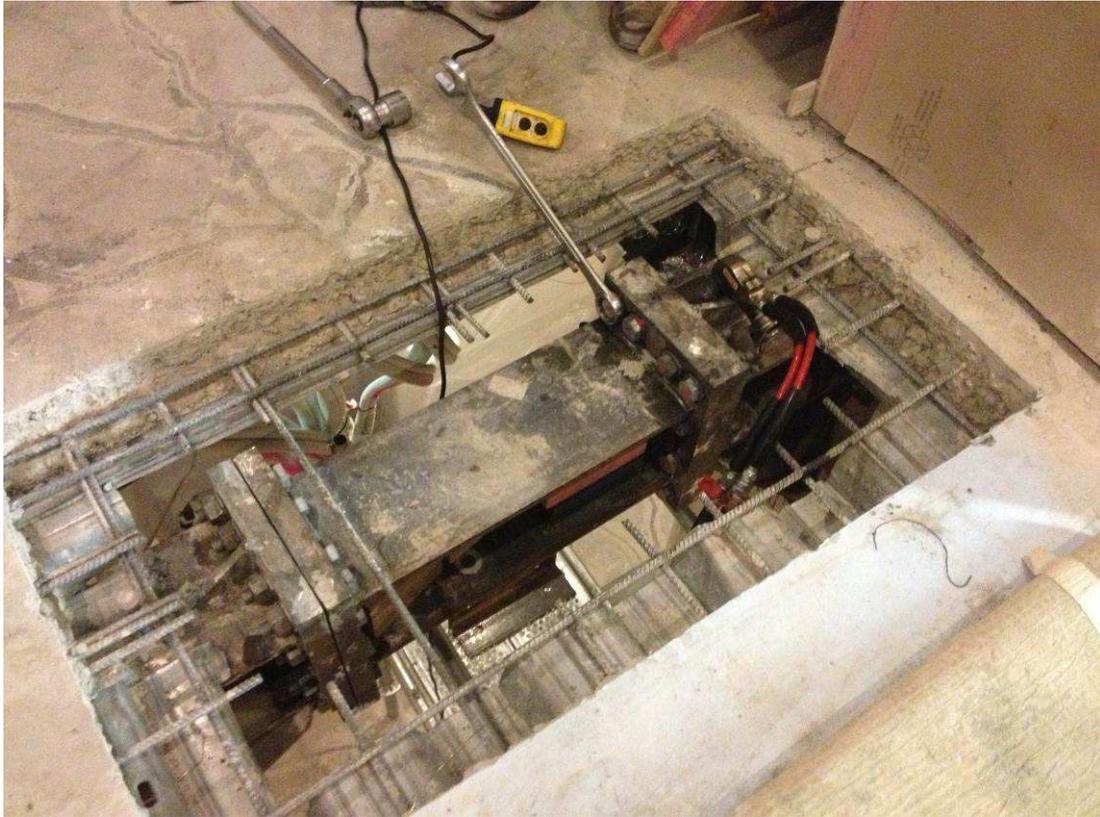
Figure 11: Bolted-in active link during bolt tensioning. Image Spiire New Zealand Ltd.

Some complications with the bolting installation were encountered. The endplates tended to have a slight convex nature after welding, leading initially to gaps at the edges of the plates. However once the specified full tensioning of the bolts was completed the plates were completed flush without the need for shims. The installation was further complicated by the restricted access around the endplates, necessitating specialist hydraulic gear to achieve the specified bolt tension, (refer Figure 11).

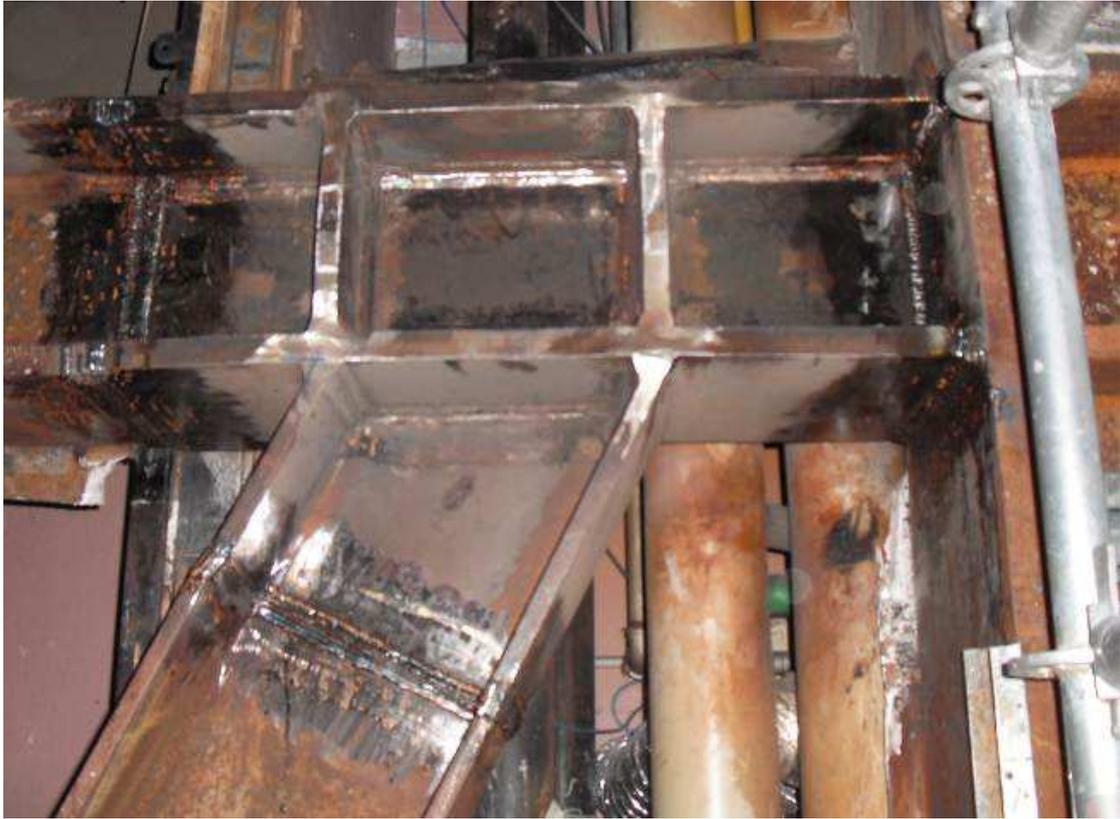
Figure 12: Welded-in active link. Image courtesy of Fortis Construction.

The remaining links were all replaced with bolted-in links except for the two fabricated Steltech links for which the active link length would have been reduced by too much as a result of the size of the endplates. These required the beams to be fabricated with Full Penetration Butt Welds between the flanges and web, and then active link sections including collector beam and brace stubs to have full section butt welds to the existing members on site (similar to the detail used on the north-west frame). Refer to Figure 12.
