## Steel Performance in the Padang Earthquake 2009

*Author:* Clark Hyland  
*Affiliation:* Hyland Fatigue and Earthquake Engineering  
*Author:* Scott Miller  
*Affiliation:* Silvester Clark Ltd  
*Date:* 30<sup>th</sup> October 2009  
*Ref.:* EQK1001

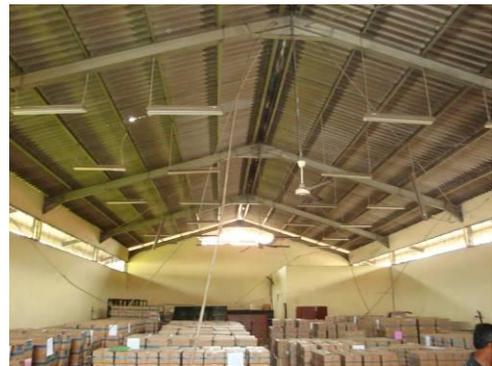
**Figure 1: Collapsed Diagonal Rod Roof Bracing**

Failure of diagonal rod bracing in roofs occurred due to weld attachment failures and also the 'unhooking' of hooked turnbuckle tensioners. Almost all the roof bracing of the fully cross braced roof of the heavy brick walled warehouse had fallen to the floor (Figure 1). Is it possible that the flexibility of the pitched roof portals may have been too much for the roof plane bracing?

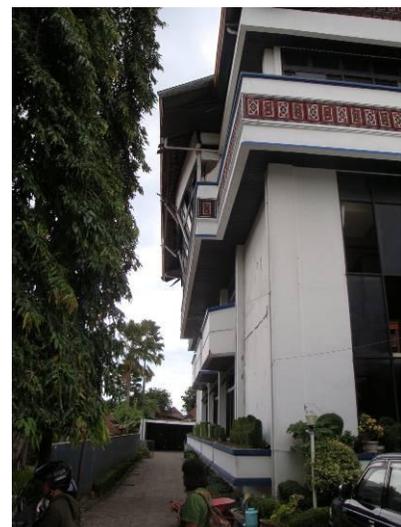
**Figure 2: Wall Panel Separated from Roof**

Reinforced concrete or brick wall cladding panels broke free from steel roof structures under face loading resulting in dangerous falling hazards (Figure 2).

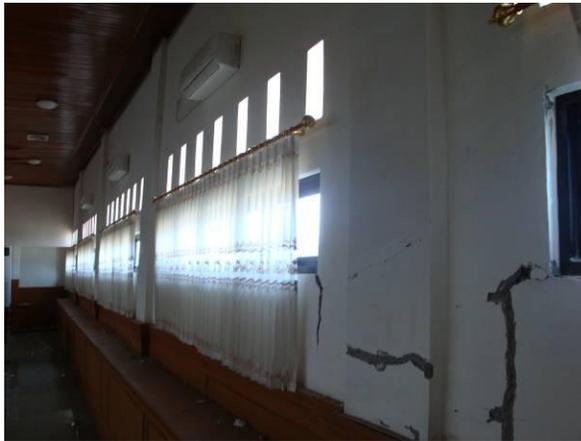
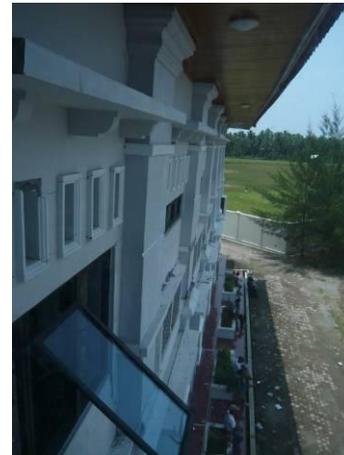
This was one of the more interesting cases we came across. This type of failure was encountered on one building and it has caused some significant damage and need for rebuild (Figure 3). The building had a heavy roof tile (porcelain) supported on timber purlins and steel frames pitched at a steep angle to the middle. The steel frames did not have a collar tie (or any other tie) and so the cantilevered concrete columns on the perimeter carried the lateral spread loads from gravity loads. When the earthquake has hit the roof frames have shaken from side to side and imposed additional lateral loads to the top of the cantilevered columns. The columns have suffered significant flexural damage and have not recovered to their original position. The roof has pushed the columns out and now rests around 500mm out of position on both sides.

Figure 3: Inside and Outside Views of Lateral Displacement in Roof Support Columns

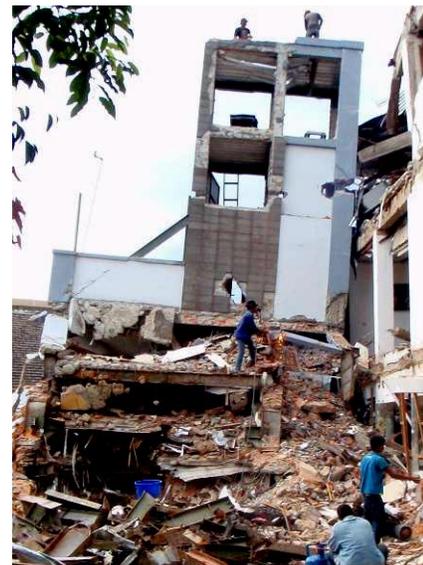
A five storey two way steel frame with metal decking collapsed in a pancaking manner, with weak axis column hinging (Figure 4). The frame appeared to have been partially concrete encased and also infilled in places with brick panels. The mode of failure indicated strong beam / weak column design, inadequate strength and lack of consideration of second order effects.

Figure 4: Steel MRF Weak Axis Collapse of 5 Storey

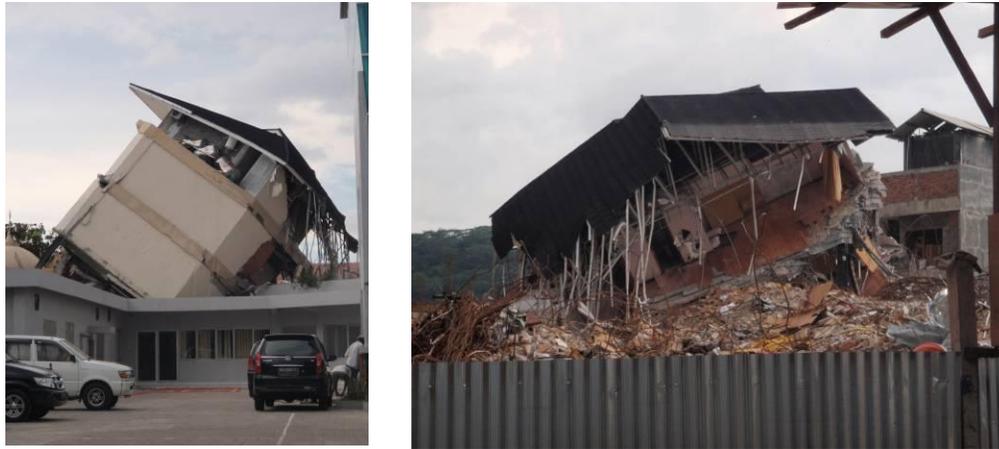
This two way steel frame building with infill brick panels (Figure 5), collapsed in what was likely to have been Level 1 to 2 column combined bending / compression buckling. 200 people lost their lives in this collapse.

**Figure 5: Collapsed Steel MRF with Partial Brick Infill Viewed From Each End**

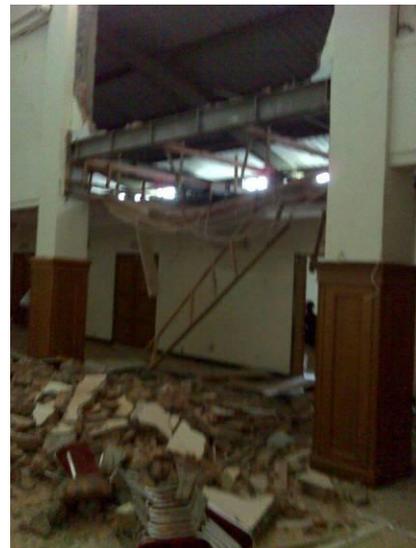
Unreinforced masonry walls that have little restraint were often seen to have collapsed in out of plane failure as was seen in this building (Figure 6). In a number of cases these collapsed over emergency egress ways or in public assembly spaces.

**Figure 6: Collapsed Brick Infill Panel Above Public Area**
