STEEL STANDS THE TEST OF TIME

The view that greets visitors arriving at Aotea Square is of a tall, slender building presiding over the public space – the Civic Administration Building (CAB). Built in 1966, the former Council building is an important piece of Auckland's architectural history.

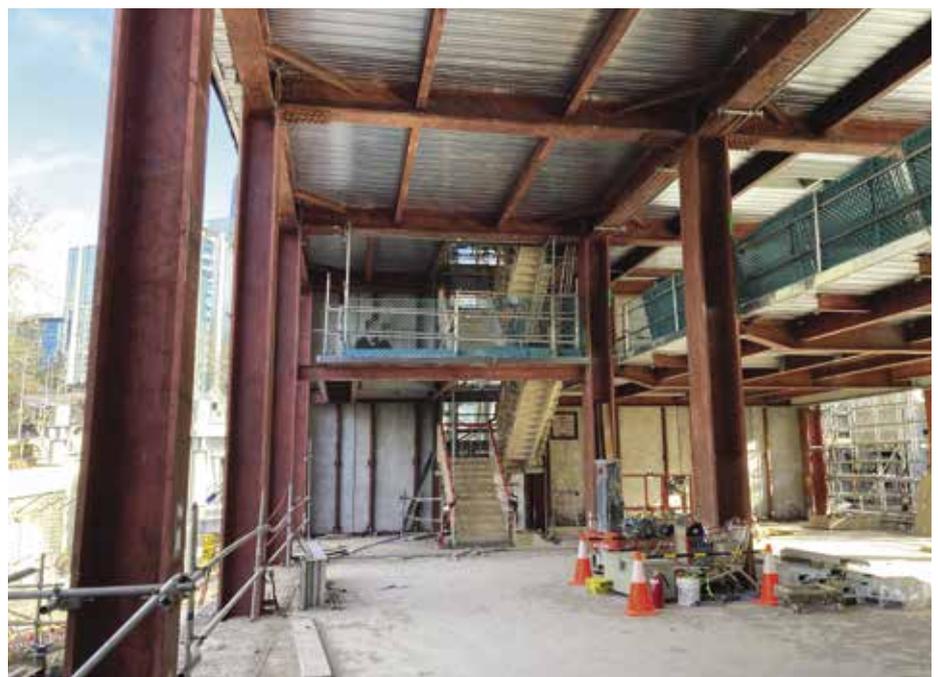
BELOW: THE STEEL WAS IN EXCELLENT CONDITION THANKS TO ITS PROTECTIVE FIRE- AND CORROSION-RESISTANT COATINGS.

The painted steel frame's condition was of particular importance, specifically any sign of corrosion. Calculated corrosion rates showed that the existing paint system didn't require any upgrade although some additional corrosion protection was undertaken for elements at the perimeter.

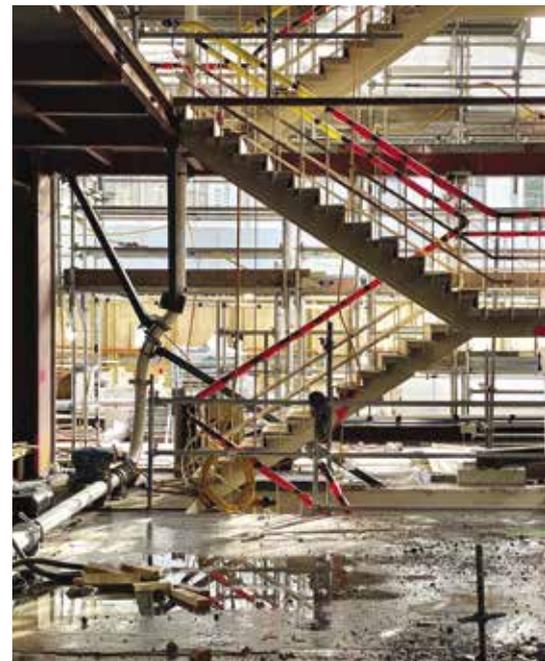
A SEISMIC ASSESSMENT OF THE BUILDING'S PRIMARY STRUCTURAL SYSTEM SHOWED THAT ITS LIKELY PERFORMANCE IN AN EARTHQUAKE STACKS UP WELL WITH TODAY'S STANDARDS.

Beca undertook a seismic assessment of the building's primary structural system to determine if its likely performance in an earthquake stacks up with today's standards - it passed with flying colours.

But the staircases, which are connected to the floors, required some modifications. The staircases are a heritage feature - the stairs, stringers and handrails were carefully designed and detailed by the architect of the day. As a building rocks during an

earthquake the floors slide relative to one another and it was important that the stairs didn't attract load as a result. So, the team recommended relatively minor retrofits to ensure the staircases wouldn't impact the building's seismic performance.

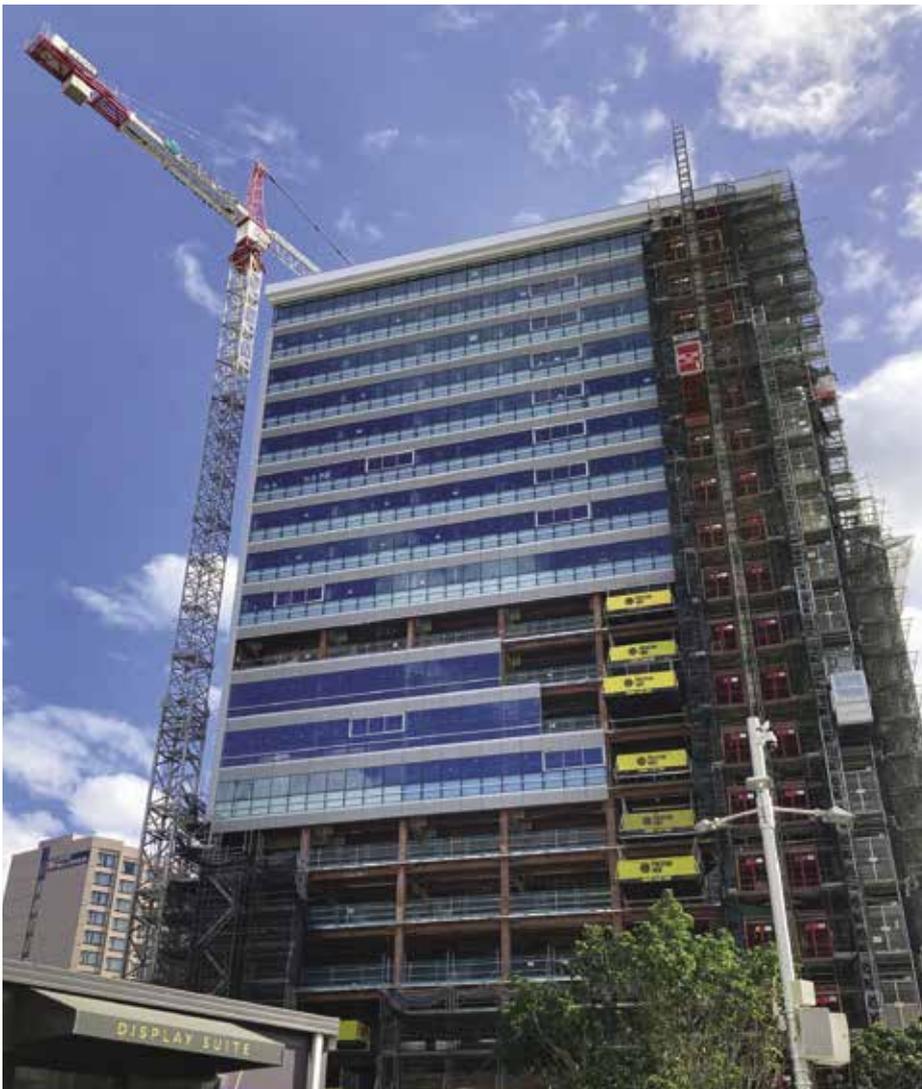
ABOVE: THE STRUCTURAL STEEL ELEMENTS OF THE CAB WERE FOUND TO BE VERY SOUND.

structural steel elements of the CAB are very sound; however, the same couldn't be said for the concrete floors, which weren't fit for purpose in a residential setting because the acoustic rating between apartments was poor. The team considered various techniques to try to compensate for the lack of acoustic performance but, ultimately, it came down to time and cost, and it was better to take out the floors and start again.

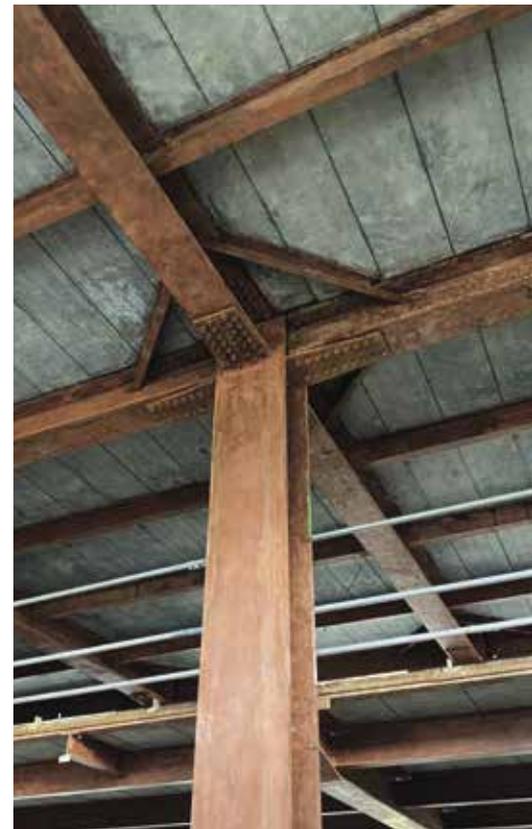
LEFT: THE BUILDING WAS STRIPPED BACK TO BARE STEEL AND THE TEAM WORKED IN BLOCKS OF FOUR FLOORS FROM THE TOP DOWN, REMOVING THE OLD FLOORS AND REPLACING WITH A STEEL COMPOSITE FLOORING SYSTEM.

It meant the building had to be stripped back to bare steel. It's not ideal to be 18 storeys in the air, demolishing floors. To maintain stability, the team worked in blocks of four floors, removing the old flooring and replacing with Tray-dec, a steel composite flooring system. But first, the entire building was scaffolded. It was a top-down programme because the roof and the parapet had to be redone before the team could progress.

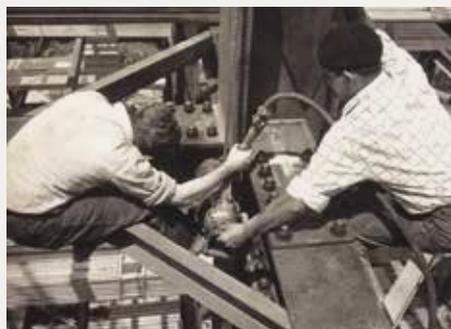
BOTTOM: ALL OF THE BUILDING IS EFFECTIVELY BOLTED TOGETHER, AS OPPOSED TO BEING A WELDED STRUCTURE.

All of the building is effectively bolted together, as opposed to being a welded structure. The team found that the

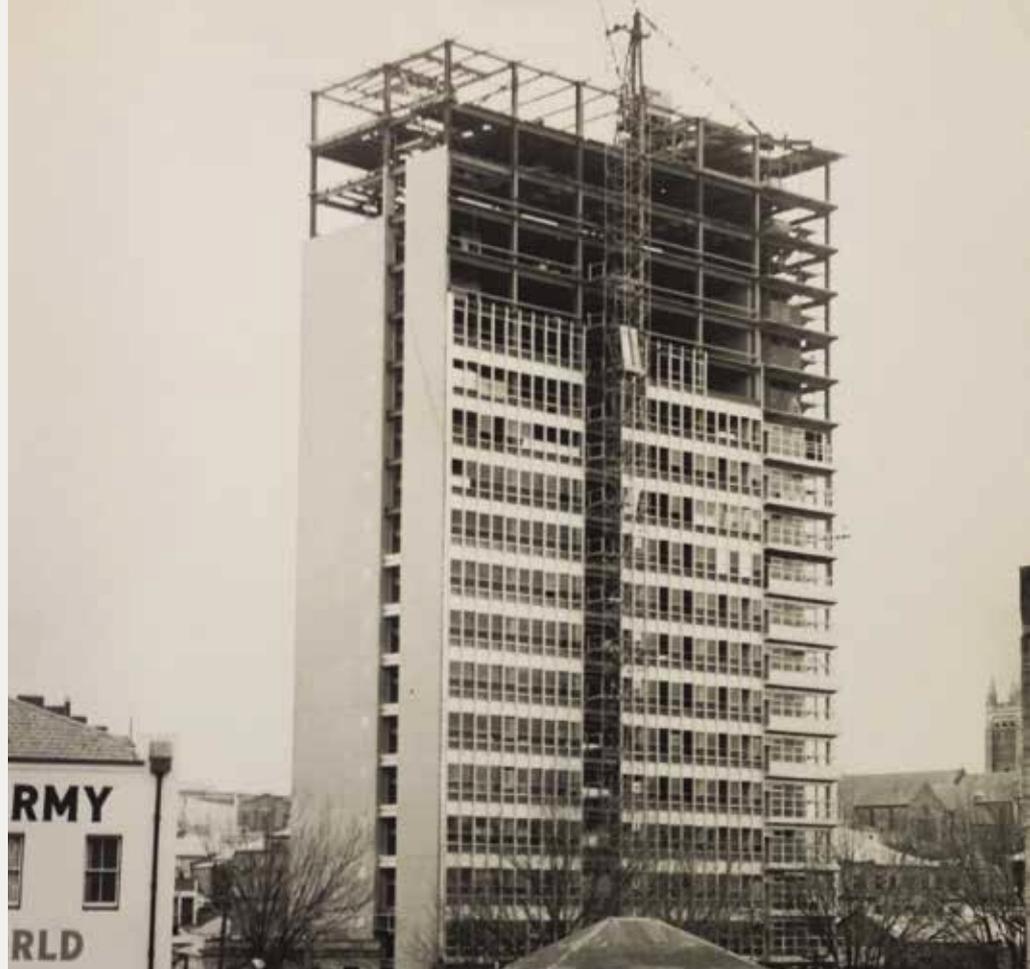
ABOVE: THE BUILDING IS A STEEL FRAME WITH BOLTED MOMENT CONNECTORS TO TRANSFER EARTHQUAKE LOADING TO THE FOUNDATION - IT IS THE MOMENT CONNECTORS THAT MAKE THE DESIGN SEISMICALLY SO RELEVANT TODAY.

Blume recommended using a steel frame with bolted moment connectors to transfer earthquake loading to the foundation. It ensured that the building was not just an aesthetic reflection of the international style but that it also captured structural advances of the day. And it is the moment connectors that make the design seismically so relevant today.
