COVERING THE FIELD – DESIGN AND CONSTRUCTION OF FORSYTH BARR STADIUM ROOF

T.W. Robertson¹

ABSTRACT

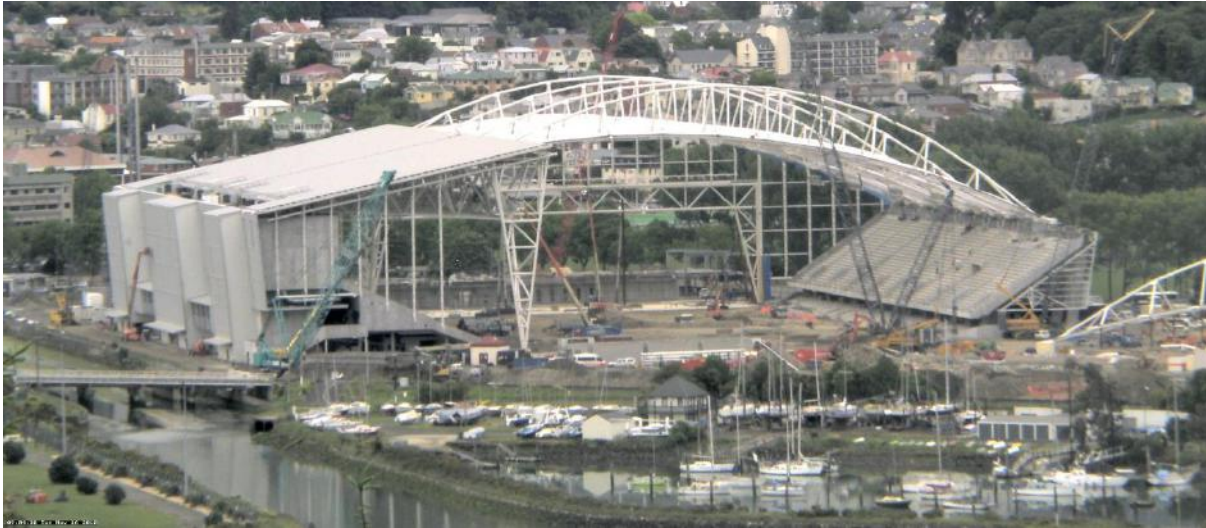
The solution developed was a permanently closed transparent roof spanning across the field between a major stand to the south and a lesser stand to the north (Figure 1). This arrangement angles the roof towards the low sun's rays for beneficial presentation of light to the turf. The air movement requirement is achieved by having multiple and quite large openings around the sides of the stadium and at strategic locations at roof level so as to generate venturi/chimney effects.

Figure 1: Under Construction - 16 Nov 2010

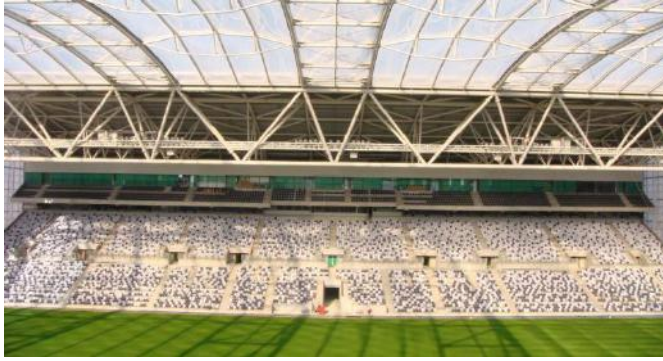
The South Stand (Figure 2) is the major stand which also incorporates corporate, hospitality and back-of-house activities. The stand is five storeys on a 10m longitudinal structural grid and a variable transverse grid. The stand is substantially concrete construction utilising precast systems for beams, rakers, bleachers and flooring but with in situ-poured columns.

Figure 2: Main Roof, Primary Truss and South Stand

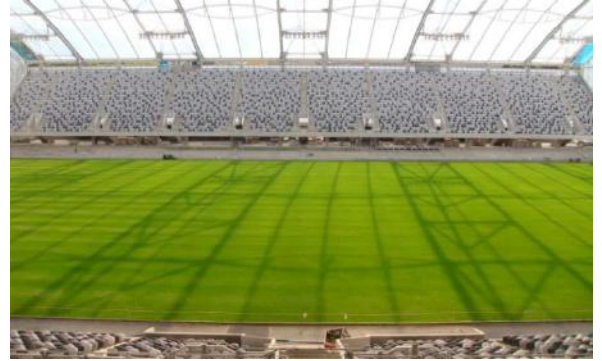
The North Stand (Figure 3) is a single tier spectator stand with the only facilities provided being those to serve the patrons of that stand. The rakers, columns and bleachers are all precast concrete. Longitudinal stability is primarily provided by concentric steel bracing between the rear (northward) concrete columns

Figure 3: Main roof structure and North Stand

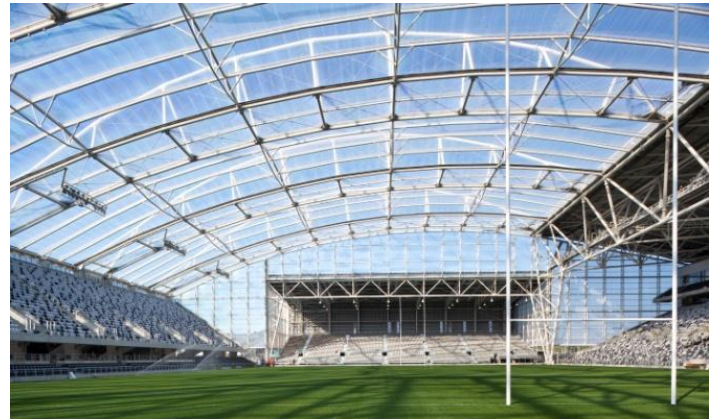
The East and West ‘Stands’ are flat floor areas at the goal-post ends of the fields, with roof over and semi-enclosing walls on the three sides away from the playing field. The enclosing super-structures are constructed in lean-to form in cross section but with the open side supported by their own transverse truss portals spanning across the width of the field (but behind the dead-ball line) (Figure 4).

Figure 4: Roof structure with East Stand beyond

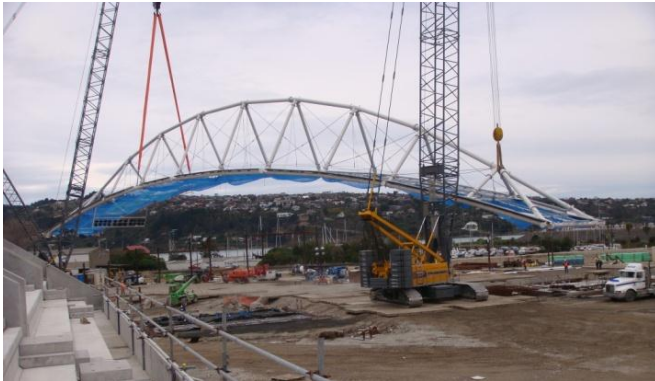
The Main Roof has five 10m-wide triangular trusses (Figure 6) that span 101m across the playing field and to the back of the North Stand. These are referred to as 'Arch Trusses' due to their shape but they work in truss action not arch action. The northern end of the arch trusses are on bearings fixed to the tops of the columns of the North Stand, free to slide N/S but constrained E/W (Figure 7). The southern supports of the arch trusses are by means of pin connections to the north top chord of the primary truss. Out-of-phase seismic response of the two supporting stands, some allowance for seismic ground spreading and significant thermal movement meant that connecting rigidly to both stands was undesirable.

Figure 6: Arch truss being maneuvered across the site

The legs of the Primary Truss were assembled at their respective ends of the site prior to erection. The Primary Truss main span was, logically, assembled more or less mid-field. Being a 350 tonne lift clearly manoeuvring the assembled truss needed to be minimised. However site logistics required each Arch Truss to be assembled at the east end of the site and then transported to the lift location utilising two very large cranes (Figure 6).

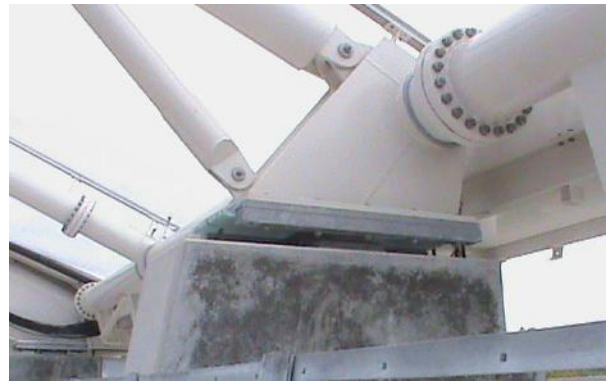
Figure 7: Bearing at north end of an ETFE transom

In particular thermal expansion was provided for at the north stand support of the arch trusses (Figure 7) and also expansion differentials between the hanging facades and the east/west enclosure planar (front) trusses (Figure 9).

In the north-south direction the roof is restrained entirely by 14 ductile seismic dissipaters connected to the top of the South Stand (Figure 8). At the North Stand the vertical load of the roof is supported on the column tops but a sliding bearing frees the roof to move independently along the north-south axis (Figure 7). The roof members are designed and detailed for the over-strength of the dissipaters.

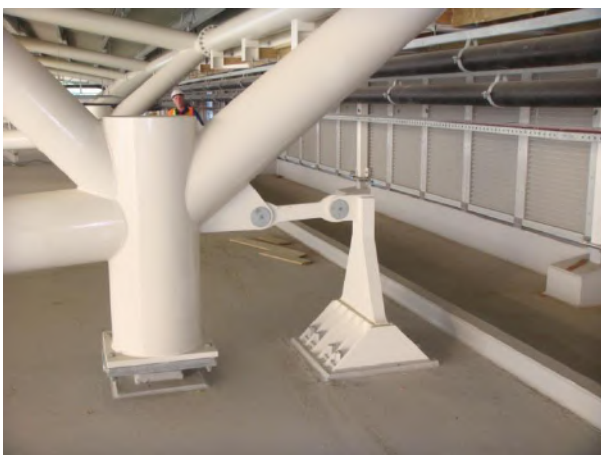
The South Roof spans between the South Stand uppermost level and the primary truss and is formed from alternating 10m wide triangular trusses and planar trusses, such that there is a top chord on every 10m grid. Their southern supports are by way of bearings that can slide N/S but are constrained E/W. To achieve a rigid connection of N/S roof loads the southern roof trusses are connected to the stand structure via steel seismic energy dissipaters (Figure 8).

Figure 8: Energy dissipater restraining South Roof

The steel tapered plate dissipaters are modelled on research by Tyler [4]. Usually this type of dissipater is included at the base of a base-isolated building or between a bridge deck and its buttresses. For the stadium, a novel approach was taken by including them between the stand and the roof. The logic of this location was to prevent or limit seismic dynamic response of the heavy concrete structure from causing high responses within the roof structure, thus causing an increase in critical roof member sizes

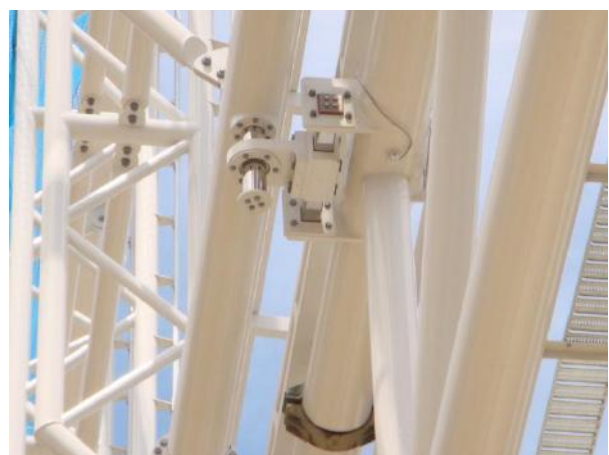
Figure 9: Two directional bearing between west hanging-facade and West Stand planar truss. Provides for vertical and longitudinal movement but lateral restraint.

The East and West facades are largely hung from out-riggers on arch trusses 1 and 5 (Figure 5) but also have a gravity support to ground where they meet the East and West Enclosures. Lateral (wind) loads from the lower edge of these hung walls is gained through several horizontal props to the North and South Stands (where appropriate) but over the East and West Enclosures the facade and enclosures are interconnected for E/W lateral loads while releasing interconnection in all other directions via a complex box bearing that allows movement N/S, up/down and rotation in all directions but not E/W translation (Figure 9).

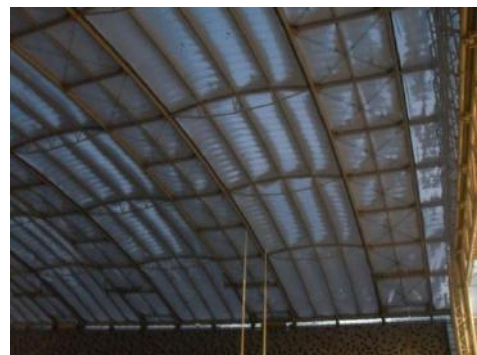
Although the roof is curved there are quite large regions that are near flat. Because of the low values of roof slope at various points the effect of accumulated snow was found to be a dominating gravity load case. The area is sub-alpine with a code defined ground snow load of 0.9 kPa. This was converted to a roof load with consideration of the roof height, slope, shape and re-entrant features. This led to snow loads of 0.63 kPa over the flatter regions of the roof dropping to 0.45 kPa over steeper sloping regions. The snow loads were considered for both fully distributed and alternate span situations to allow for uneven build-up due to eddy effects and/or snow sliding locally from the steeper roof slopes (Figure 10).

Figure 10: Roof under light snow load

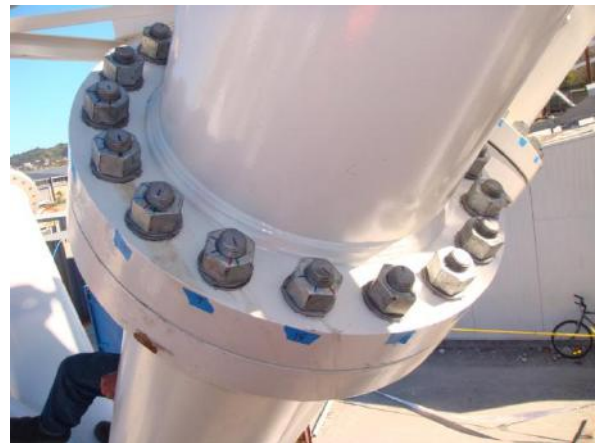
The various truss components were originally designed as all welded construction, as is common for major stadium roof structures. This, however, would have necessitated considerable site welding, placing demands on time, quality and painting requirements. The main contractor was appointed prior to completion of design and it made it very clear that to meet the tight time demands in a location such as Dunedin it was essential that all site joints were by means of fabricated bolted flanges. After much discussion it was recognised that there were a number of critical joints where flanges would not be sufficient and site welding was still required. These locations were primarily the primary truss lower chord joints. All other joints between fabrication assemblies were flanged (Figure 11). It is generally accepted that the project would not have been completed on time without this decision.

Figure 11: Typical flange joint

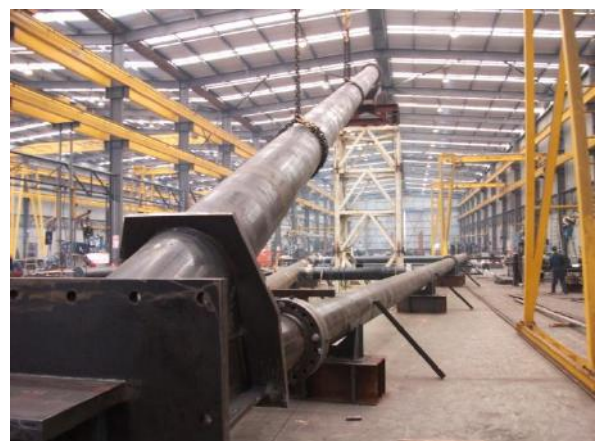
Figure 12: Trial assembly of Primary Truss leg

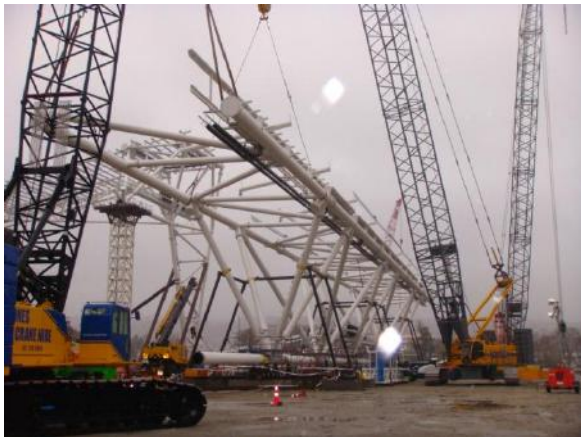
Figure 13: Primary Truss assembly

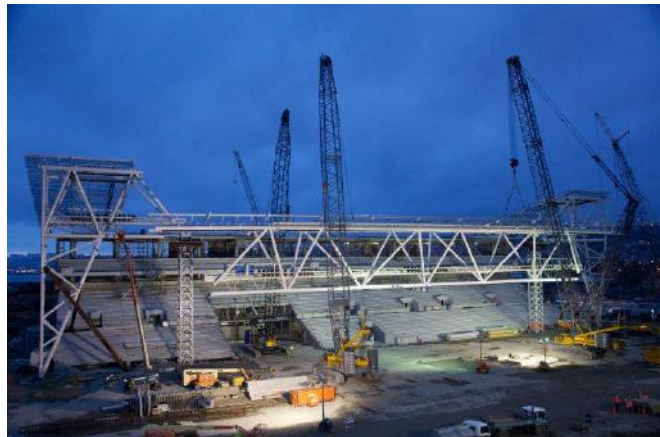
To lift the Primary Truss main span required sections of the South Stand bowl seating bleachers and support beams to be delayed in order to enable the erection cranes to back into the space to minimise crane reach. This main lift commenced at about 5:00 am and was completed by nightfall. The splices to the already erected sections above the truss legs were to be site-welded which provided only 4mm clearance at each junction for lifting in the 350 tonne main span.

Figure 14: Primary Truss lifting
