EXPERIMENTAL TESTS OF INTERNAL COMPOSITE STEEL FRAMES AGAINST PROGRESSIVE COLLAPSE

B. YANG¹ and K. H. TAN²

ABSTRACT

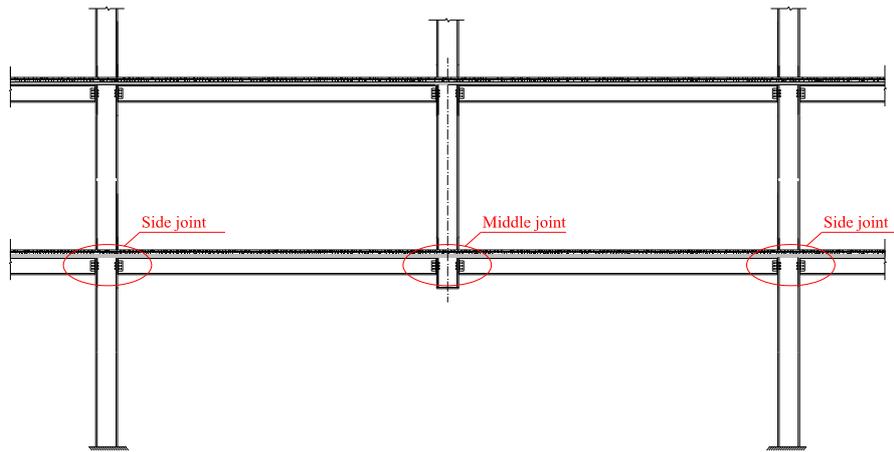
Figure 1. Composite frame subjected to a middle-column-removal scenario

In the alternate load path method, the middle joint above the removed column shown in Figure 1, is subjected to a sagging moment while the side joints are under hogging moments. Due to the presence of composite slabs above steel joints, the structural behaviour of side and middle composite joints, including flexural and catenary resistances and rotation capacities, is different with each other. Yang and Tan (2012) presents a series of experimental tests of composite beam-column joints under a middle-column-removal scenario. It consisted of two types of tests, namely, middle joints under sagging moment and side joints under hogging moment. For the middle and side joints, it was observed from the experimental results that the obtained load-displacement curves were quite different. At flexural action stage, the load-carrying capacities of the side joints were much greater than the middle joints. In this series of tests, an inflection point was assumed to be located at the middle of the beam span. However, during the deflection process, the inflection point may change its location due to the load resistance difference of middle and side joints. The interaction between the middle and the side joints will be studied in this paper by experimental tests. The load redistribution after the column removal will be addressed.

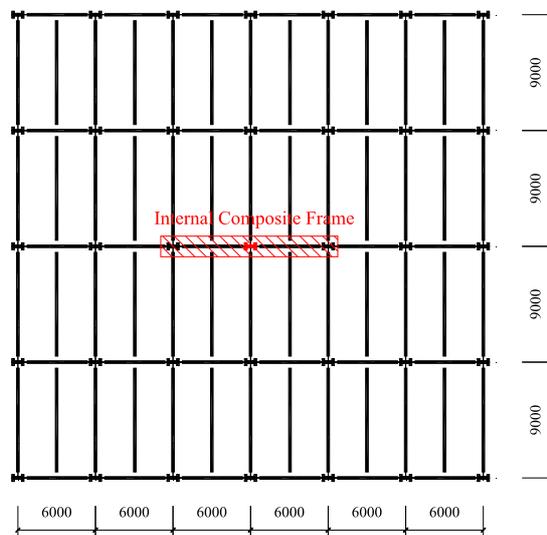
Figure 2. Plan view of the prototype internal composite structure

The plan view of the prototype composite structure is shown in Figure 2. As shown in Figure 2, the considered Internal Composite Frames represents full horizontal restraints, which are provided by the surrounding structural elements. The vertical loads are applied under in-plane loading condition. Due to space limitation in the laboratory, the test specimens were scaled down to 1/2 of their original size.

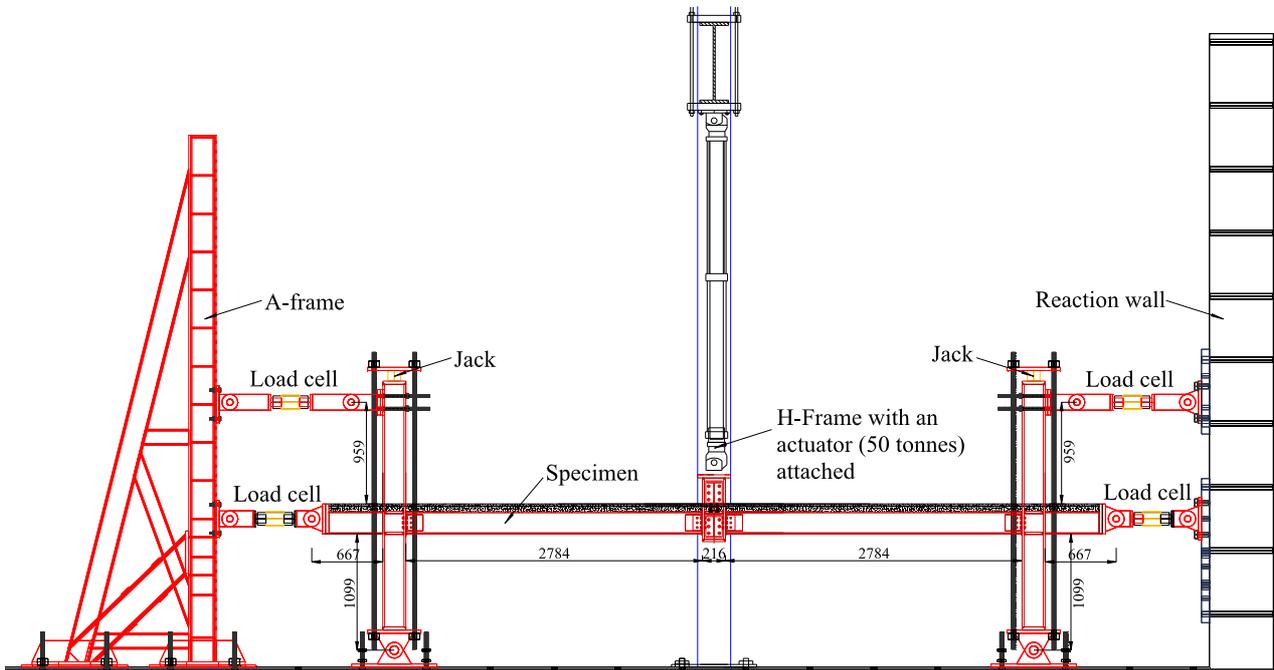
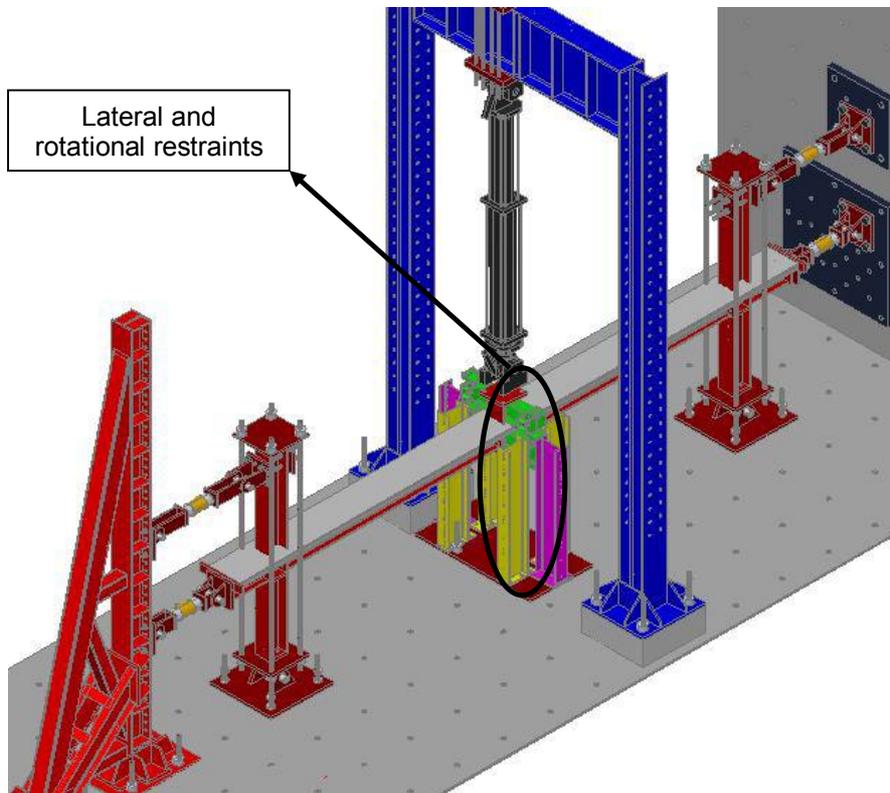
(a) Front view

(b) Aerial view

Figure 3. Test set-up (unit: mm)

Figures 3 (a) and (b) show the test set-up for the frame specimens. The top and bottom ends of the two columns were connected to the pin supports, which represent the restraints of the surrounding structural elements. In addition, the extended beams were also horizontally restrained by two pin-pin connections. As shown in Figure 3, the horizontal restraints in this test set-up are provided by an A-frame and a reaction wall. Four load cells have been used in order to measure the horizontal reaction forces. The horizontal reactions at the column bottom ends are obtained by the bending moments of the steel column sections, which are measured by strain gauges.

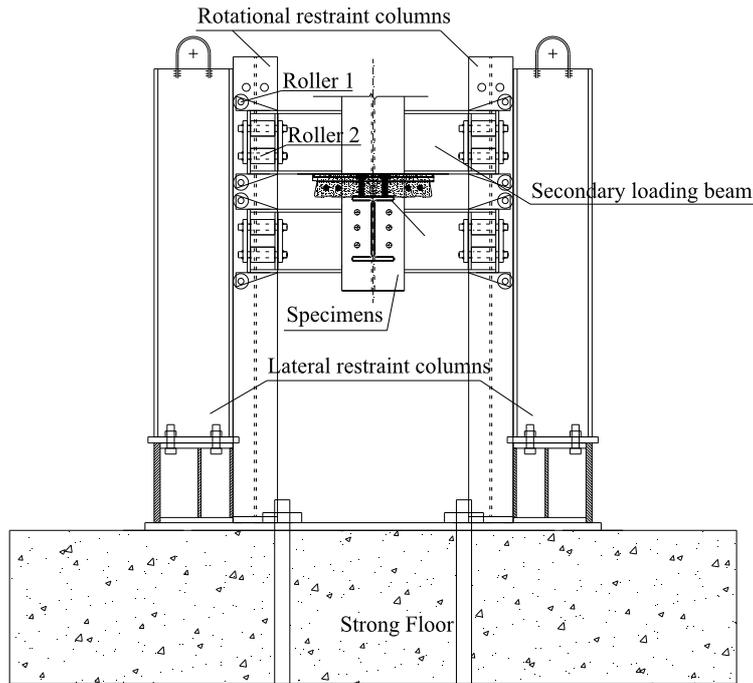
Figure 4. Lateral and rotational restraint systems

To consider the effect of column axial forces on the behaviour of the internal composite steel frames, hydraulic jacks were installed at the tops of the two columns to apply constant axial loads onto the columns. In order to consider the rotational restraint to beam-column joints from the continuous column of upper storeys, the test rig included a rotational restraint system at the mid-span, as shown in Figure 4. The column rotation was restrained by sixteen steel rollers (Roller 2 shown in Figure 4), which would bear against the flanges of four steel columns during testing. In addition, the beam-column joints were restrained from lateral

movement by a lateral restraint system (Roller 1 shown in Figure 4). A displacement-controlled point load was applied to the middle column using an actuator, which was reacted against a strong H-frame. Load was applied under displacement control at a rate of 6 mm/min. A pair of secondary loading beams shown in Figure 4, was also connected to the middle column, to ensure the line load could be applied onto the composite slabs directly.

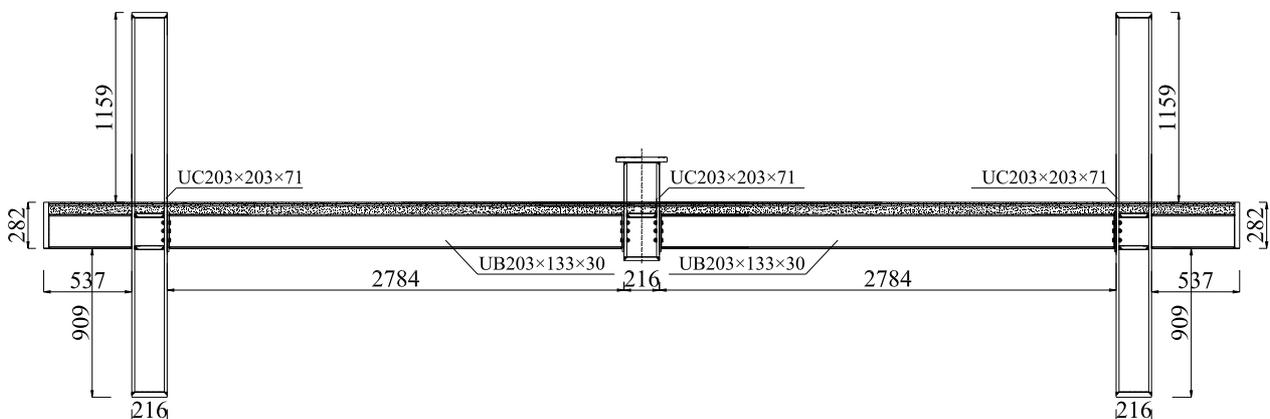
Figure 5. Layout of the internal composite steel frame specimens

All specimens had the same total length of 7,290 mm. The configurations of the specimens are illustrated in Figure 5. In this experimental programme, two types of connections including web cleat and flush end plate connections, were tested. All the connection details of these two types of connections are shown in Figure 6. Two types of reinforcement details have been tested in this series of experimental programme. One type of reinforcement details is steel mesh with 4T13 bars and the other type of reinforcement details is steel mesh only. The beam and column cross-sections of all the specimens were the same, viz. UB254×146×37 and UC203×203×71. The beams and columns were strengthened by some stiffeners or welded thick plates to limit the influence of beam and column deformations on the connection behaviour. As shown in Figure 6, two rows of shear studs with a displacement of 90mm were welded along the steel beams in order to ensure the full shear connection between steel beam and composite slab. The details of the four composite joint specimens are also presented in Table 1. The reference used for the specimens follows the nomenclature *I-W(F)-MT(M)* where *I* represents internal composite frames, *W* represents web cleat connection, *F* represents flush end plate connection, *MT* represents the reinforcement of steel mesh and 4T13 bars and *M* represents the reinforcement of steel mesh. For instance, in *I-W-MT*, the specimen represents the *internal composite steel frame*, the connection type is *web cleat* and the composite slab reinforcement is *steel mesh and 4T13 bars*.

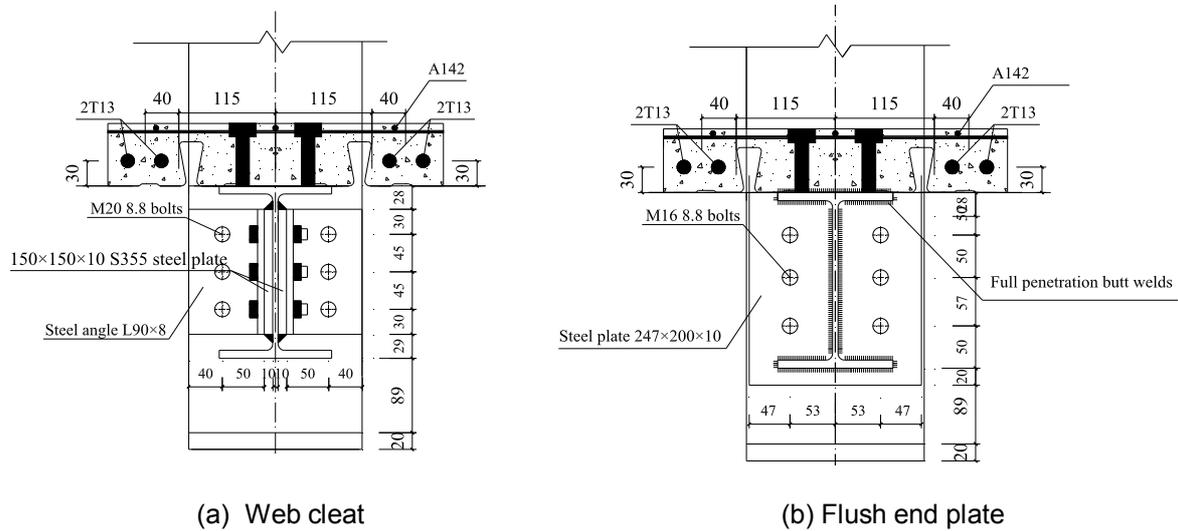
Figure 6. Beam-column joint details of the internal composite steel frame specimens

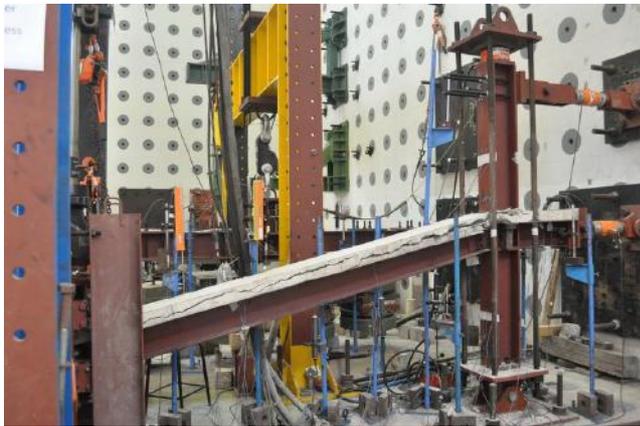
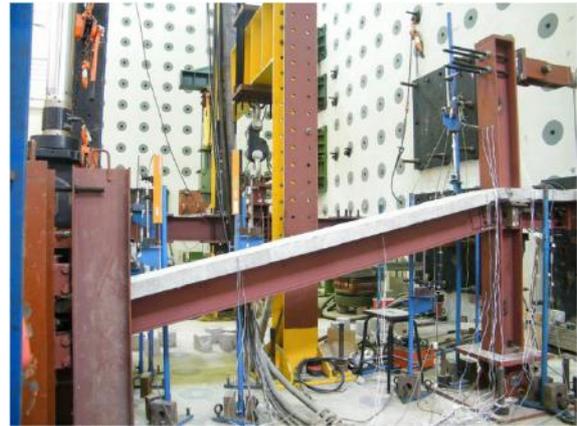
(a) Deformation of specimens with 4T13 rebars

(b) Deformation of specimens without 4T13 rebars

Figure 7. Overall deformation of composite steel frame specimens

In this section, the experimental results of four composite steel frames are presented. A summary of the test results is found in Table 3, from which the maximum vertical loads, the corresponding middle column displacement and rotation angles are given. The axial forces of beams are also included in this table. Figure 7 shows the overall deformations of the frame specimens. From these two figures it can be found that the displacement profile of each beam can be approximated by a straight line, which indicates the formation of plastic hinges at the beam-column connections. It should be mentioned that at Table 3 the joint rotation angles at maximum loads are obtained by dividing the centre column displacement at the maximum load by the beam span of 2.784m, as shown in Figure 3 (a). This simplification is reasonable because the beam deflection profiles between the plastic hinges can be approximated by straight lines.

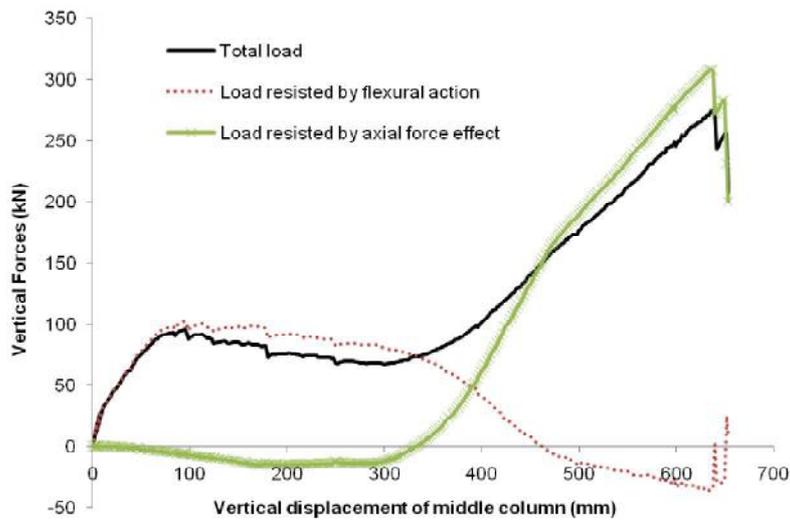
Figure 8. Vertical force-middle column displacement curve of Specimen I-W-MT

Figure 8 shows the vertical force-middle column displacement relationship for Specimen I-W-MT. It can be seen that at the initial loading stage, the applied load was resisted by flexural action while at large deformation stage, the load was resisted by catenary action. Figure 8 shows that catenary action could not be mobilized until the vertical displacement of the middle column was greater than 300mm. The failure mode of this specimen is shown in Figure 9. At a displacement of 96mm, a longitudinal crack formed in the composite slab, which has been shown in Figure 7 (a). The longitudinal crack indicates the bond-slip failure of T13 reinforcing bars in the composite slab. However, the bond-slip failure does not mean the failure of reinforcing bars. T13 bars could still resist the applied load like cables. Concrete crushed severely in compression during testing at the middle beam-column joint, as shown in Figure 9. One of the web angles fractured at a displacement of 640mm, which caused a significant reduction of applied load. Finally, one of the T13 reinforcing bars at the left side beam-column joint fractured at a displacement of 652mm, which has also been shown in Figure 9.

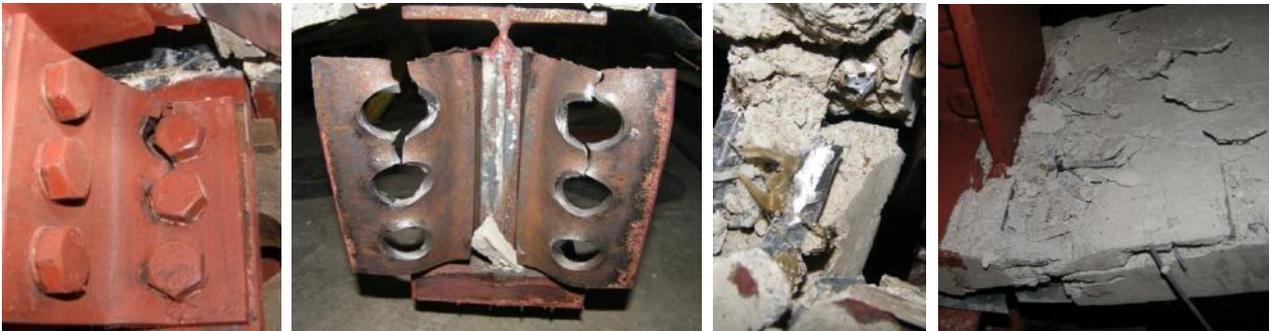
Figure 9. Failure mode of Specimen I-W-MT

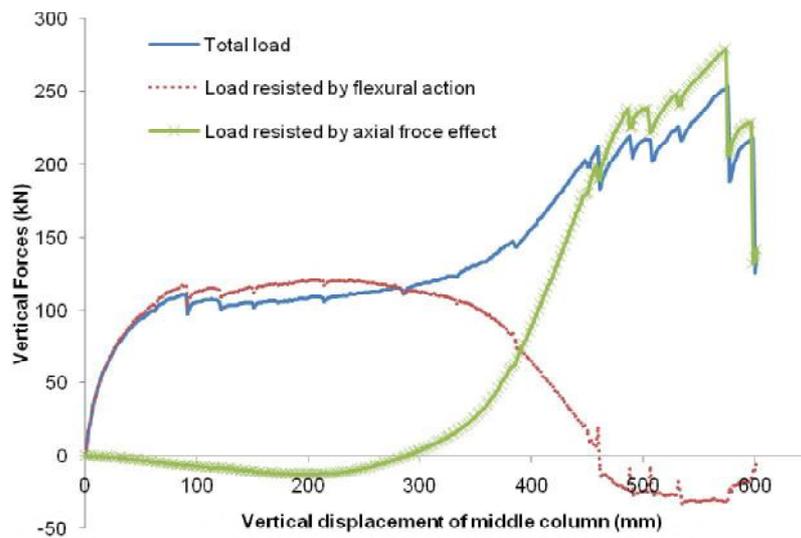
Figure 10. Vertical force-middle column displacement curve of Specimen I-F-MT

Figure 10 shows the force-displacement history of Specimen I-F-MT. Similar with Specimen I-W-MT, the force-displacement history can be divided into two stages: flexural action and catenary action. Figure 11 shows the failure mode of this specimen. At a displacement of 460mm, one of the bolts at the middle beam-column joint fractured. Final failure was controlled by bolt fracture at the right beam-column joints, which has been shown in Figure 11.

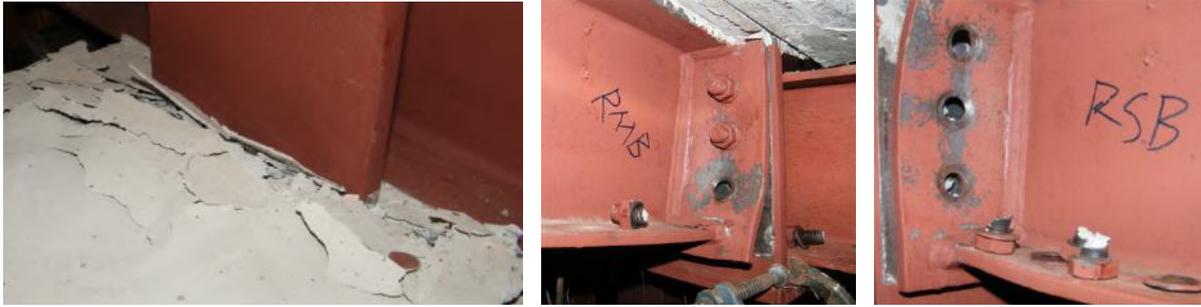
Figure 11. Failure mode of Specimen I-F-MT

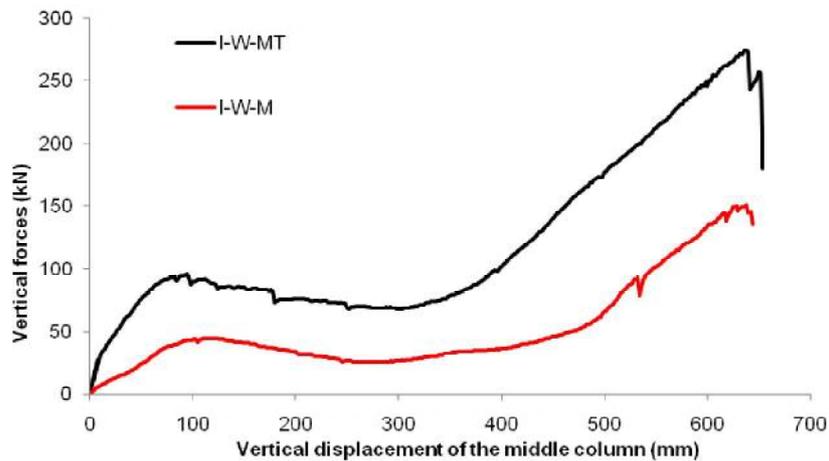
Figure 12. Vertical force-middle column displacement curves of Specimens I-W-MT and I-W-M

Figure 12 compares the force-displacement curve of Specimen I-W-MT with Specimen I-W-M, which shows the effect of 4T13 reinforcing bars clearly. It can be found from this figure that 4T13 bars can increase the load-carrying resistance not only at flexural action stage but also at catenary action stage significantly. Figure 13 shows the failure mode of this specimen. The final failure is controlled by bolted angle fracture, which is the same with Specimen I-W-MT. At large deformation stage, after the fracture of profile decking and steel mesh, the composite slab was broken completely at side beam-column joints, as shown in Figure 13. It means only steel connection (bolted angle connections) resisted the applied loads.

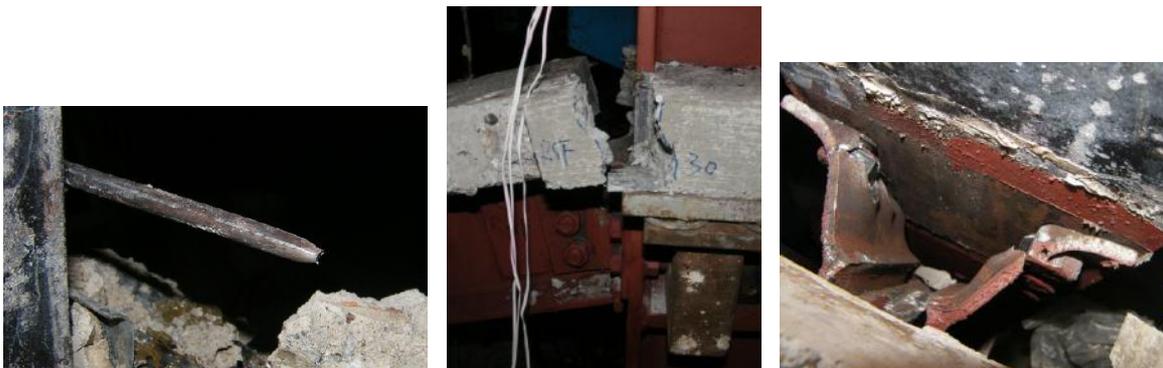
Figure 13. Failure mode of Specimen I-W-M

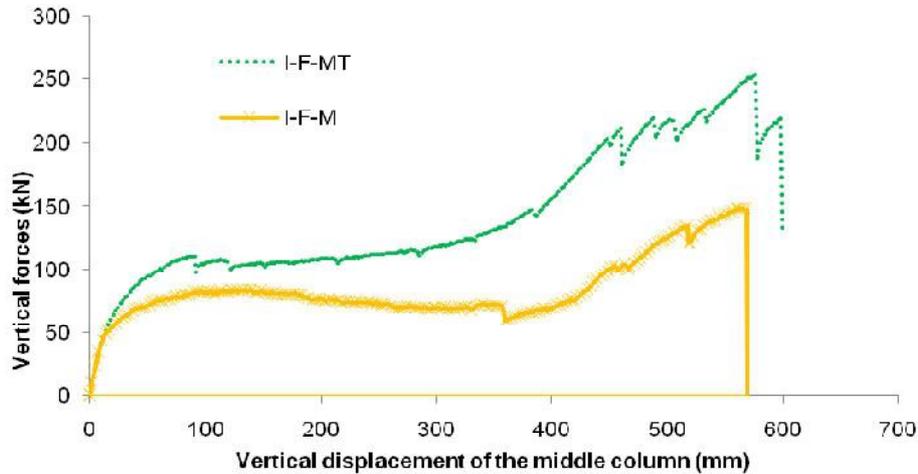
Figure 14. Vertical force-middle column displacement curves of Specimens I-F-MT and I-F-M

Figure 14 compares the force-displacement curve of Specimen I-F-MT with Specimen I-F-M. It can be found from this figure that for this type of connection (flush end plate connections), 4T13 bars can also increase the load-carrying resistance at flexural action stage and at catenary action stage. It should also be mentioned that the contribution of 4T13 bars for flush end plate connections is not as significant as web cleat connections, especially at flexural action stage. This is because flush end plate connection belongs to semi-

rigid connections, which have higher flexural resistances than simple connections like web cleat connections. Therefore, the increase of load-carrying capacity caused by 4T13 reinforcing bars is relatively lower than web cleat connections. Figure 15 shows the failure mode of this specimen. The final failure is controlled by bolt fracture, which is the same with Specimen I-F-MT. To be similar with Specimen I-W-M, at large deformation stage, after the fracture of profile decking and steel mesh, the composite slab was broken completely at side beam-column joints, as shown in Figure 15, and only steel connection (flush end plate connections) resisted the applied loads.

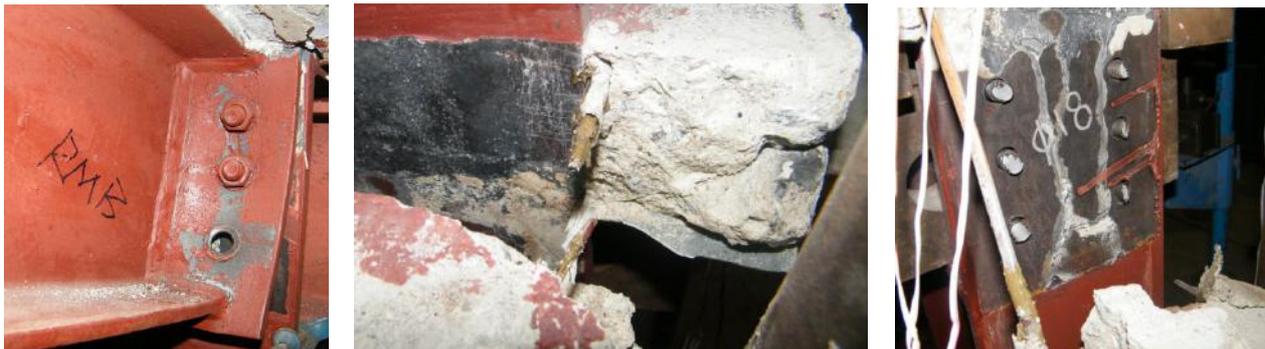
Figure 15. Failure mode of Specimen I-F-M
