## The Performance and Remnant Life of Structural Steel in an Earthquake Damaged Building

### Part A

### Part B

# Failure Analysis of the Active Link in an Eccentrically Braced Frame

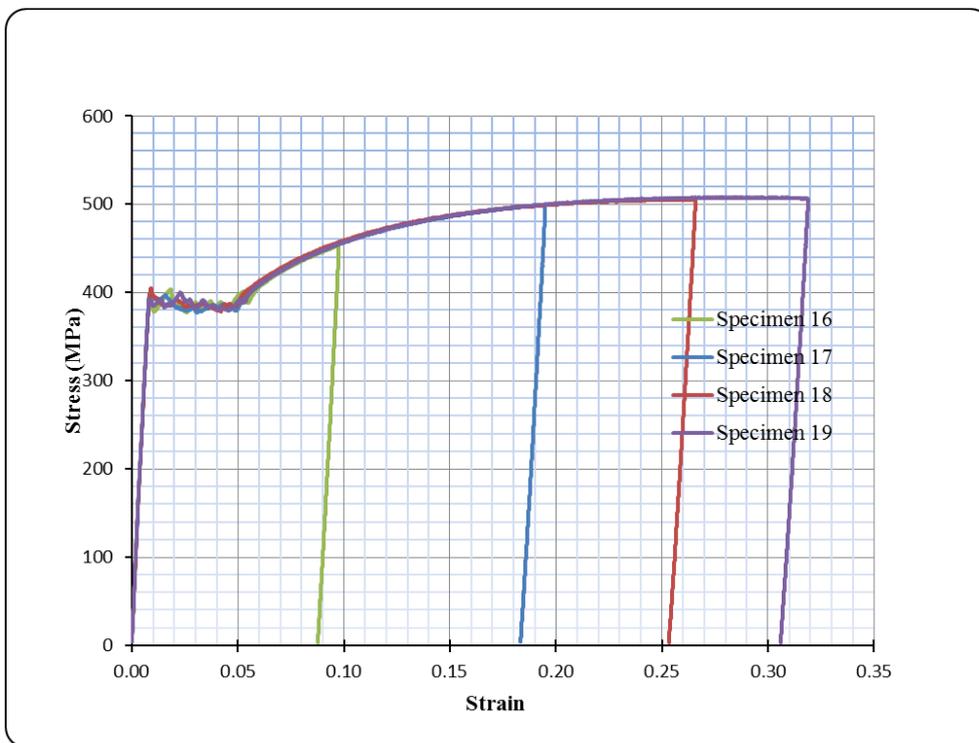
**Figure 1** Stress – Strain curves for tensile specimens S16, S17, S18 and S19

The research discussed below has been undertaken by Hassan Nashid, a PhD research student in the Department of Civil & Environmental Engineering, at the University of Auckland. The experimental work and method are detailed in a paper to be presented to the 2013NZSEE Conference<sup>14</sup>. To commence the investigation into using hardness as method for determining plastic strain in deformed structural steel, tensile specimens made from Grade 300MPa steel, were loaded to various plastic strains as shown in Figure 1.

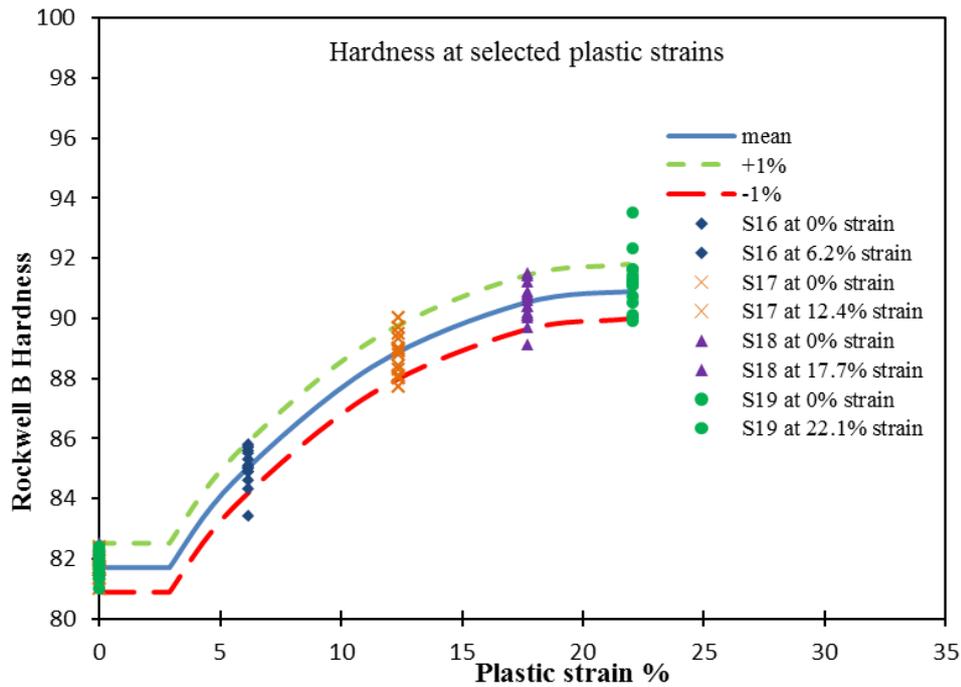
**Figure 2** Hardness versus Plastic Strain relationship for 8mm thick tensile specimens

After deformation the Rockwell B hardness was measured on each specimen numerous times and the results are plotted in Figure 2, where Rockwell B hardness is plotted against percentage plastic strain. This figure then is a correlation of hardness with plastic strain and can be used to determine plastic strain in a similar steel that has been plastically strained. The inherent errors in the process can be noted from the range of Rockwell B data at each strain. This correlation should not be used with the data from the remainder of the paper because the steels are not the same. Another way to make the correlation is to plot flow stress against hardness and from such a curve determine flow stress and relate this to plastic strain from the stress-strain curve for the steel. This method does not reduce the inherent errors in the hardness method.

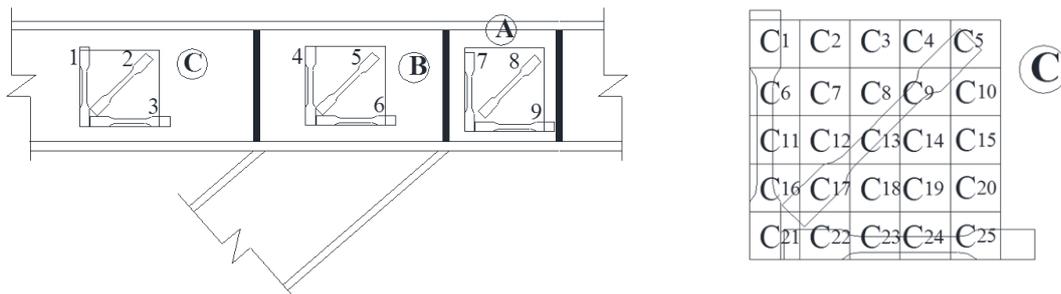
**Figure 3(a)** Tensile specimen locations in zones A, B & C of the active link beam **Figure 3(b)** Hardness test grid for zone C (Similar for zones A & B)

Hardness and tensile tests were conducted on the web of an EBF system which had been plastically deformed during the 22<sup>nd</sup> February 2011, earthquake and removed from level 3 of the Pacific Tower. The EBF system was divided into three test zones as shown in Figure 3(a): Active Link Zone (Zone-A), Panel Zone (Zone-B) and Beam Zone (Zone-C), and the tests were conducted on the web section of each zone. Three tensile specimens were, water jet cut, from each zone as indicated in Figure 3(a) and hardness tests taken in a grid pattern as indicated in Figure 3(b) where there were 25 test locations and at least 6 tests were

done at each location. Both Rockwell B and Leeb, model TH170, hardness testers were used<sup>14</sup>. The Leeb TH170 is a portable hardness tester<sup>15</sup>, which enables on site testing, but requires careful surface preparation with the surface roughness being less than  $1.6 \mu\text{m}$  and the test specimen needs a minimum weight<sup>14</sup> of 5 Kg.

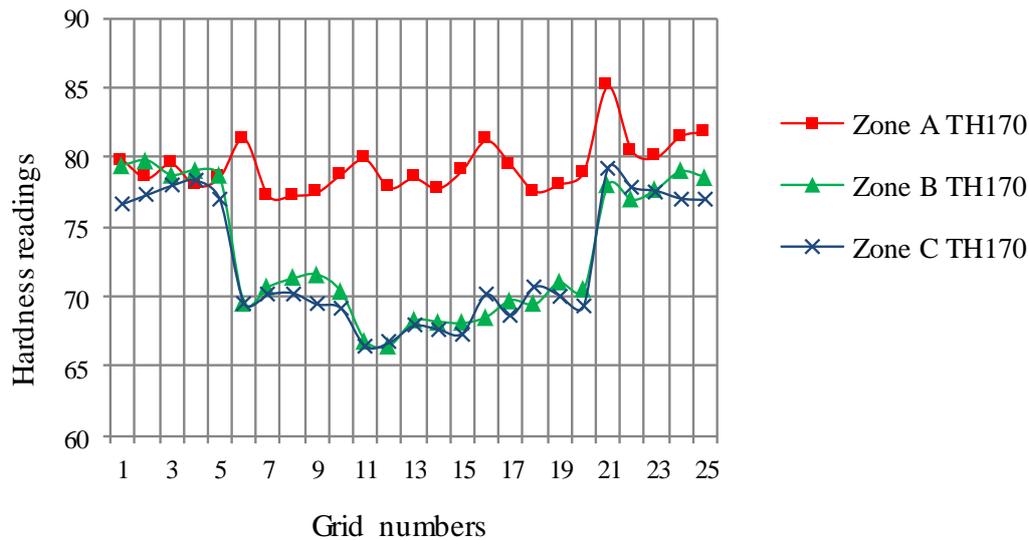
**Figure 4** Rockwell B hardness versus grid numbers in zones A, B & C of the active link beam from level 3, Pacific Tower (Leeb hardness tester)

The Leeb hardness, which can be read as a Rockwell B hardness, for each of the grids in zones A, B & C is plotted in Figure 4, as hardness Rockwell B versus grid number. It can be seen the hardness in zone A, the active link, is within the scatter, constant and higher than for the other zones. This is the zone that would be plastically deformed. For the other zones it can be seen the hardness is significantly lower in the middle rows of the grid, corresponding to the central portion of the web, where for these zones there should no plastic deformation. For the edge rows near the flanges the hardness has increased significantly to about the level for zone A, which implies there has been plastic deformation in this region next to the flanges in these zones. To examine this effect further the hardness data for both Rockwell and Leeb testers are plotted in Figure 5 as normalised link/beam depth versus Rockwell B hardness for one column of data from each of the zones A, B & C. Firstly the Rockwell B test results are about 10 points higher than for the Leeb, but both show the same trends, in that for the zone deformed by the earthquake, the hardness is essentially constant across the web between the flanges and for zones B & C there is no plastic strain in the centre of the web but there is some near the flanges and of the same magnitude as that in zone A. If the tensile stress-strain

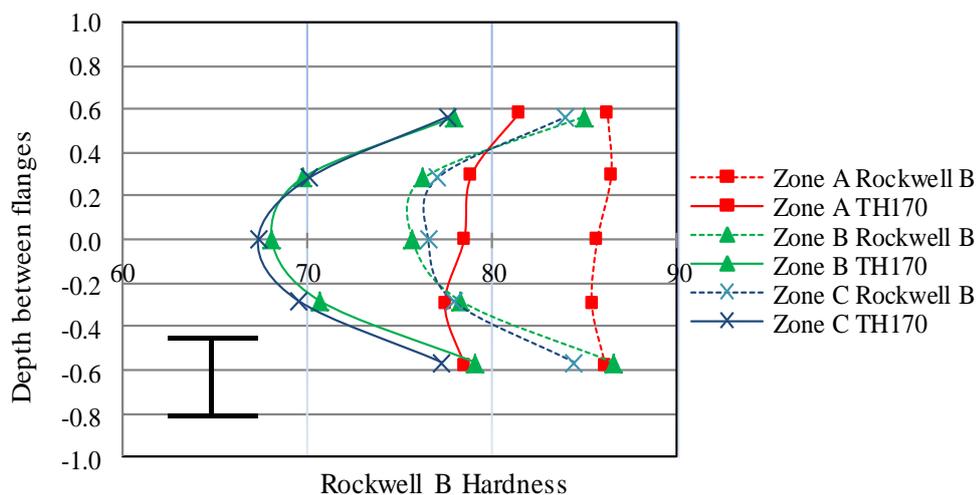
**Figure 5** Rockwell B hardness versus normalised link depth between flanges for the zones A, B & C of the active link beam from level 3, Pacific Tower ( Leeb & Rockwell hardness testers)

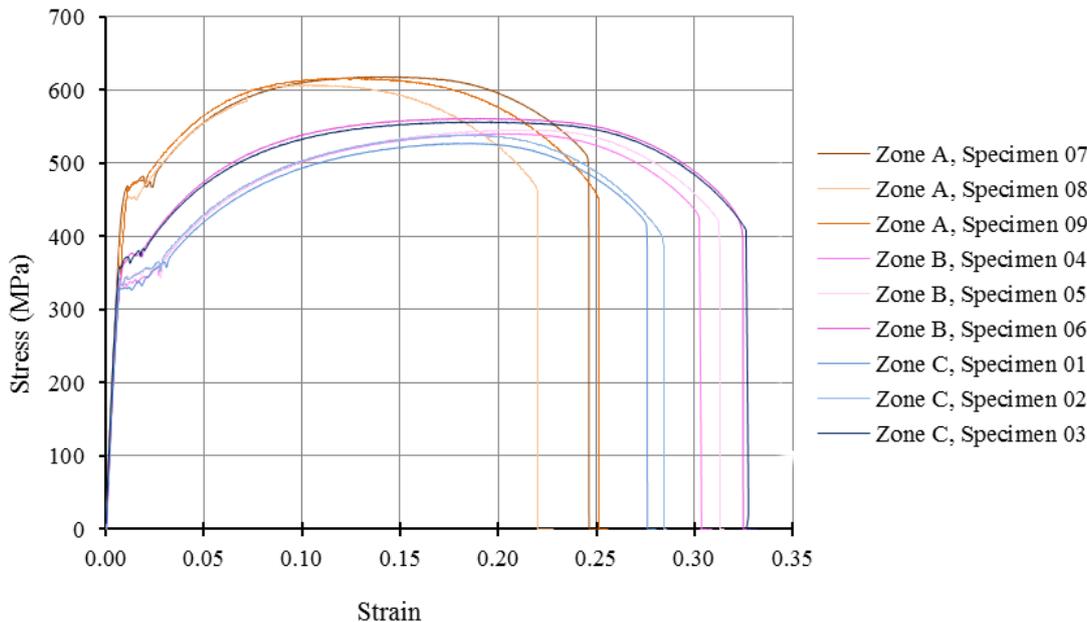
**Figure 6** Stress – Strain curves for tensile specimens from zones A, B & C of the active link beam from level 3, Pacific Tower

curves in Figure 6, for each of the tests in zones A, B & C are examined, it can be seen that they confirm the hardness results. All tests from zone A, 7, 8 & 9, have essentially the same shaped cure and flow stress which is to be expected as this web should have been deformed plastically in the earthquake. For zones B & C, tests 1, 4, 2 & 5, have essentially the same shaped yield curve and yield stress, which is to be expected as the centres of these specimens are in the centre of the web which for these zones should not have yielded. Tests 3 & 6 are near the flange, have the same shaped stress-strain curve, but the flow stress has increased over that for tests 1, 4, 2 & 5, showing there has been plastic deformation in the region of the web near the flange and confirming the hardness results. Clearly from these results, the as received beam has been plastically deformed near the flanges. The curves also show that this manufacturing plastic strain is about 3% and the plastic strain in the deformed zone A is about 7 – 7.5%.

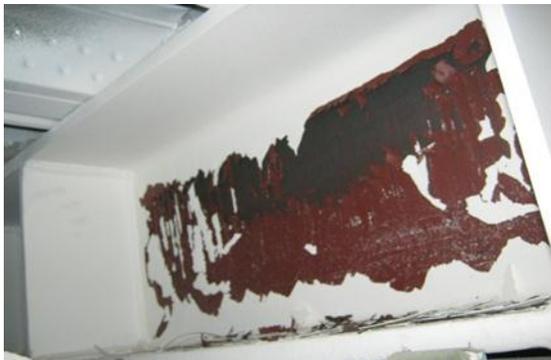
Several photographs of deformed links, one of which is shown in Figure 7, from damaged buildings in Christchurch, show the paint has peeled from the central portion of the web but near the flanges the paint is still adhering to the steel indicating it has not been plastically deformed. The initial concern was that the flanges were affecting the Leeb hardness but when the flanges were cut off and Rockwell B measurements taken the effect was still present which was confirmed by the tensile tests. A literature search showed the

**Figure 7** An Active Link beam at the Club Tower

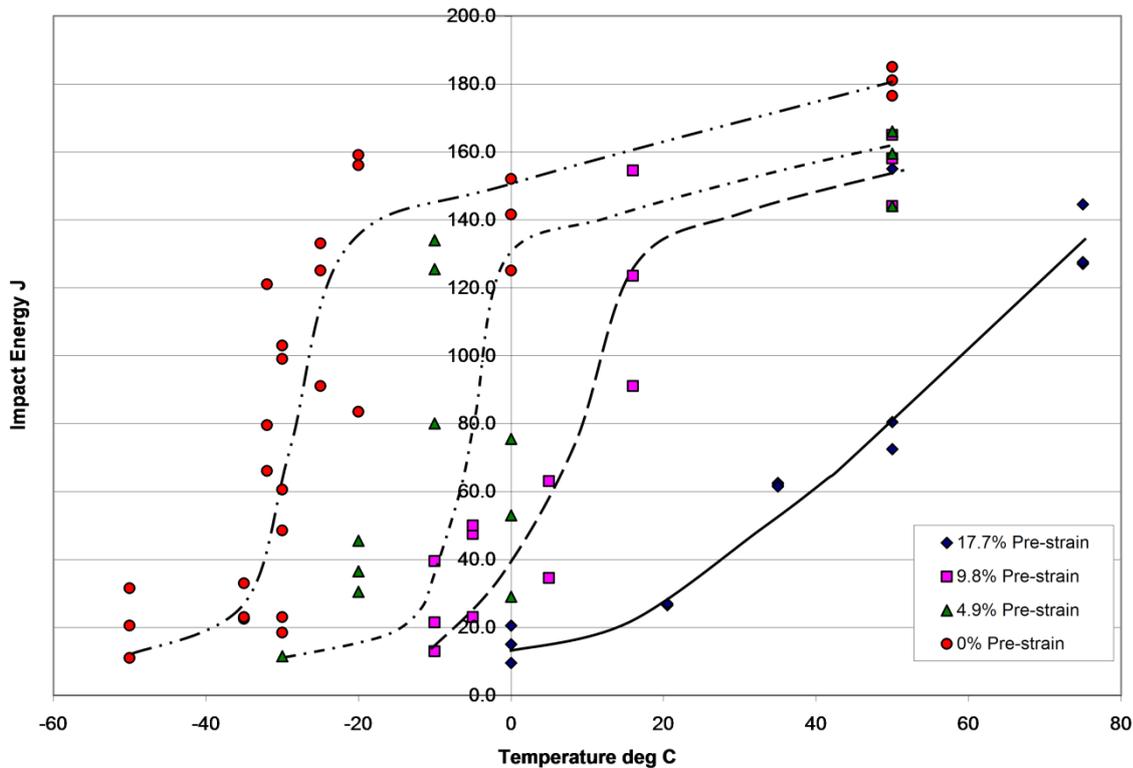
From Figure 8, the shift in the transition temperature of deformed, strain-aged steel for a plastic strain of 4.9% raises the transition temperature by about 20°C, but the steel would still meet the toughness

requirement of 70 J at 0°C. set by Standard, NZS 3404. Within the scatter it might be argued that the upper limit for the peak plastic strain, resulting from earthquake loading and still ensuring the that70 J at 0°C requirement is met, is about 7.5%, and the link examined above would meet the requirements of the standard.

**Figure 8** Charpy V-Notch transition curves showing effect of pre-strain<sup>17,18</sup>

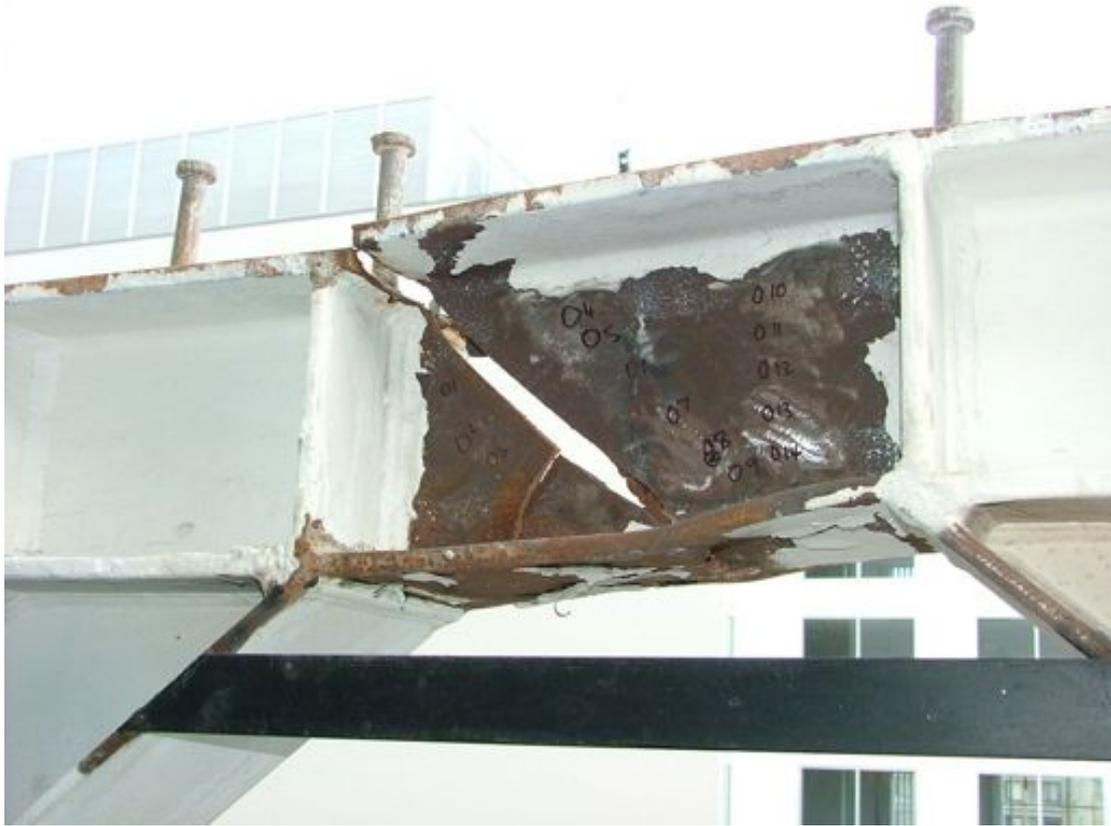
The 6.3 magnitude earthquake that struck Christchurch on the 22nd of February 2011, caused widespread damage to many structures in the city, especially the 6 buildings of around 20 storeys in the central business district. This was due to the very high intensity of this earthquake, with the highest peak ground accelerations recorded worldwide in a first world city. The 22-storey Pacific Tower, located on Gloucester St, was no exception. The eccentrically braced frames that comprise the seismic resisting systems underwent inelastic action in their active links. In July 2011, workers discovered that one of the active links in an EBF located in the Northwest corner of the tower had fractured (see Figure 1). This type of EBF fracture had not been reported worldwide in either laboratory testing or other earthquakes. The fractured link was cut out of the building and investigated further.

*Figure 1: Fractured EBF in situ.*

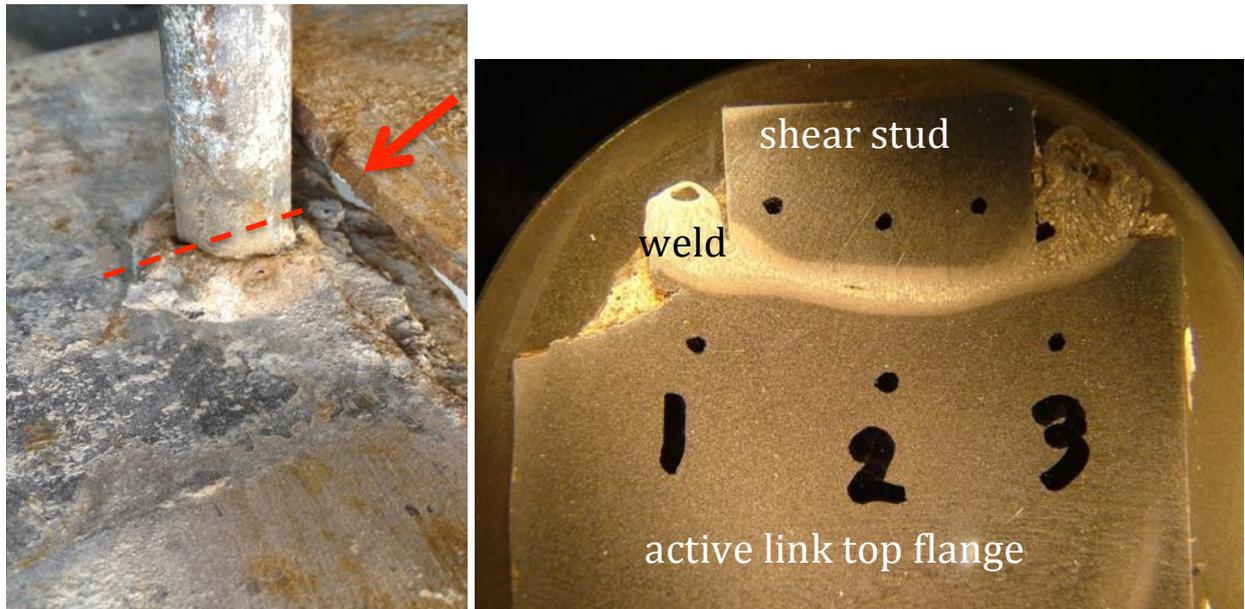
The fractured active link was removed from the building and sectioned to reveal the fracture surfaces. Examination of the fracture surfaces revealed that the initiation site was at a shear stud weld (Figure 2). Headed shear studs were welded the surface of the upper flange of the active link during construction and embedded into the concrete slab, with their role to generate composite action between these two components. Shear studs are welded within a ceramic ferrule and use the base of the shear connector itself as the weld metal. During welding they shorten by 5 - 7mm as the base of the stud and the supporting steel beam directly underneath are melted and fused together. Metallographic examination and hardness traverses of the welded zone (see Figure 2) revealed that there were slag inclusions and untempered martensite in the microstructure. Note that shear studs were located at the corners of the active link (see Figure 1), just above the stiffening plates, a location that would have needed to yield under high demands for strain in the event of lateral loads.

*Figure 2 - The red arrow indicates the initiation site is near the toe of the weld (left image). The red dashed line indicates where the shear stud was cross sectioned. Metallography and microhardness traverses through the weld of the shear stud (right image) indicate the presence of non-metallic inclusions and untempered martensite.*

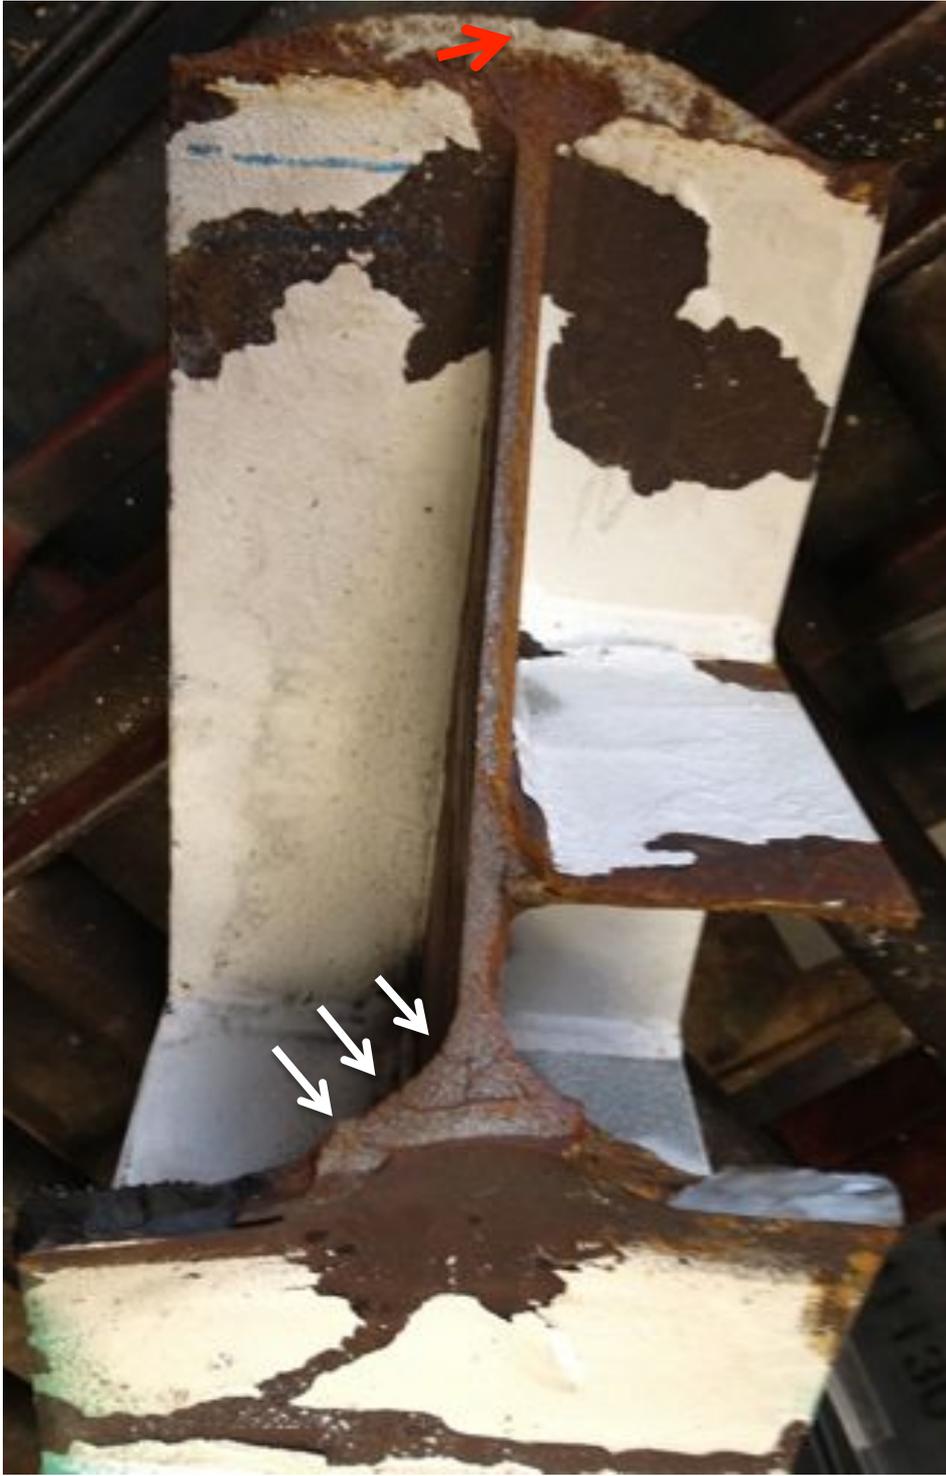
Visual examination suggested that the upper flange and web of the active link fractured in a brittle manner, due the absence of any signs of plastic deformation (such as shear lips) and presence of chevron marks. Chevron marks showed that the fracture propagated from the weld material through the upper flange, through the web, and arrested at least three times in the lower flange (see Figure 3). It is possible that the arrests correspond to three different seismic events. It cannot be ruled out that there was a large crack pre-existing the first earthquake on 4 September 2010, or the much more intense 22 February 2011 earthquake, since there was heavy corrosion and concrete on the fracture surface at the initiation site,

*Figure 3: One of the fracture surfaces. The red arrow indicates the initiation site. The white arrows show arrest marks.*

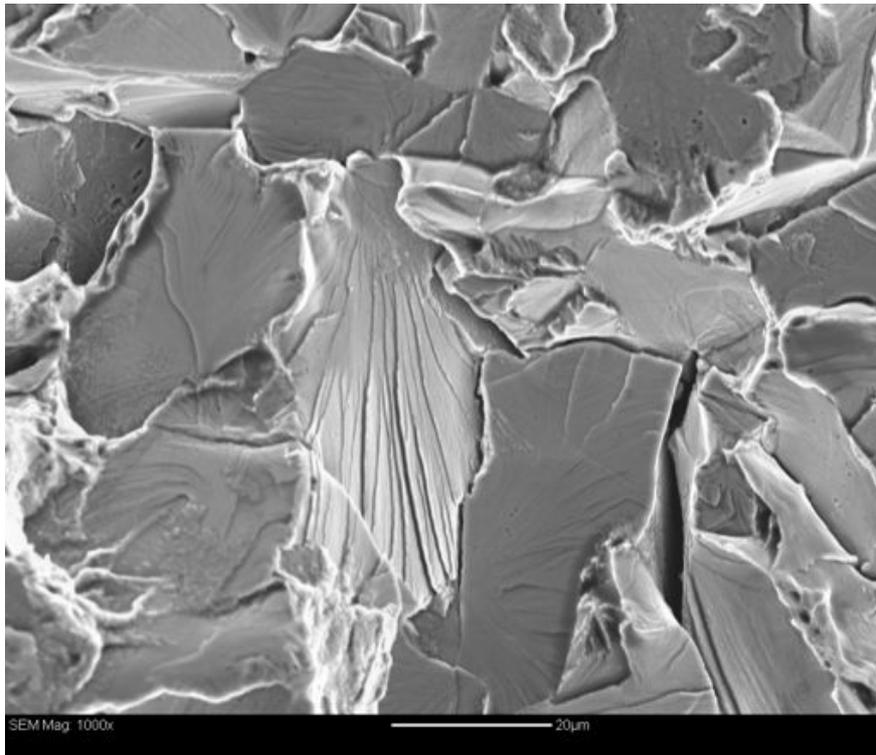
while the fracture surface through the web was relatively clean and free of corrosion. Scanning electron fractography (Figure 4) showed that the entire fracture surface was dominated by cleavage, which can only be interpreted as impact loading at a temperature below the ductile brittle transition temperature (DBTT).

Figure 4: Scanning electron micrograph showing the typical appearance of the fracture surface. The appearance is classic cleavage fracture of steel subject to impact loading below the ductile-brittle transition temperature.

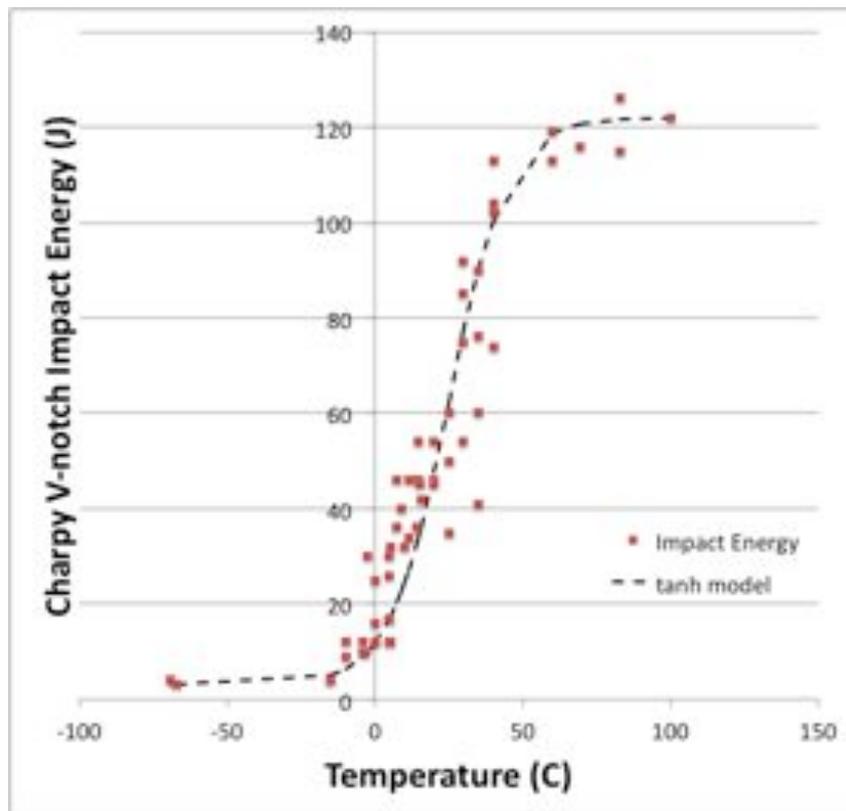
If one defines the ductile brittle transition temperature (DBTT) as the temperature as the impact energy passes through 27J, then the hyperbolic tangent model fitted to the experimental data (see Figure 5) identifies the DBTT of this material as 11.5°C. The impact energy at 0°C (relevant to grade 300L0) is only approximately 12J.

Figure 5 - Charpy V-notch energy versus temperature data with hyperbolic tangent function fit.
