Performance of the Mercer Off-Ramp Weathering Steel

Date: 5th February 2009

Ref.: MAT2001

State Highway 1 Mercer Off-ramp

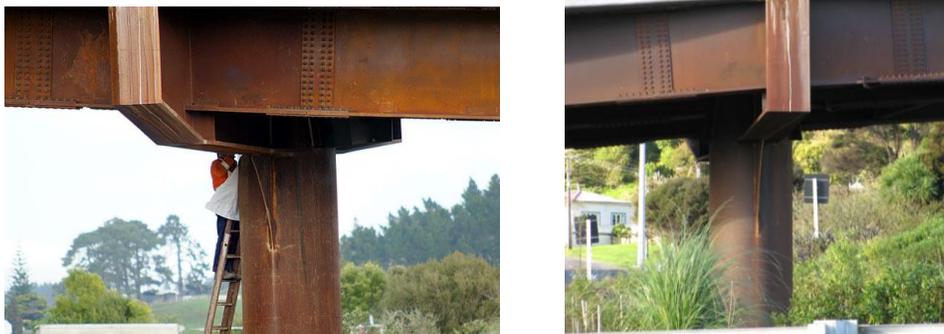
The Mercer off-ramp is in a suitable location for reliable weathering steel performance, as recommended in the New Zealand Weathering Steel Guide for Bridges (Clifton, El Sarraf, 2005). Patina formation is progressing well as expected, as can be seen in the changes in appearance of the pier, from a rusty orange colour to a fairly consistent dark brown (Figure 1).

Figure 1: Mercer Off-ramp Pier, July 2006 (left) and August 2008 (right)

In September 2008, Japanese weathering steel expert Dr Makoto Ohya, visited New Zealand and measured the patina development of the weathering steel using equipment and techniques developed in Japan (Kihira et al, 2005). He found that the maximum patina thickness measured was 125 microns and the average thickness was 90 microns, and so was developing as expected. The design corrosion loss of the weathering steel for a 100

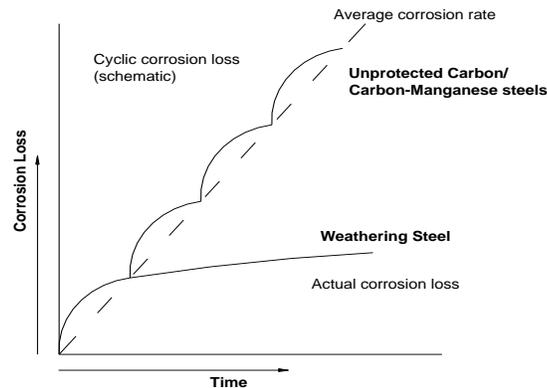
year design life is calculated to be in the order of 200 microns over the whole structure, using the New Zealand Weathering Steel Guide for Bridges. The independent measurements taken by Dr Makoto Ohya are consistent with this, as once the patina is formed the corrosion rate of the steel will reduce greatly in comparison with mild steel (Figure 3). His method could be used in future to relatively quickly and inexpensively confirm the suitability of a site for weathering steel bridge, over a two year period during planning stages.

Figure 3 Comparison of Weathering and Carbon Steel Corrosion Loss.

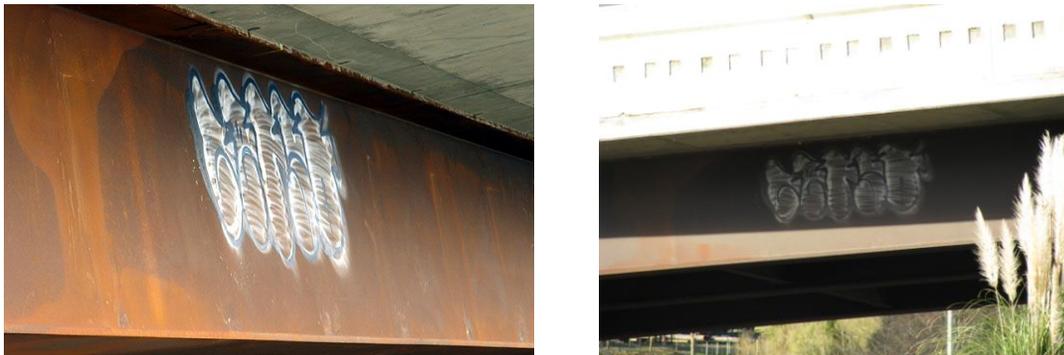
Another advantage of weathering steel is how graffiti may be dealt with. Graffiti will locally slow the patina formation while the graffiti paint breaks down, however the effect is not ultimately detrimental to the performance of the steel. In Japan a light paint coating is often applied to weathering steel located near the sea to deliberately slow the patina development in more aggressive environments. After two years, graffiti put on the off-ramp is slowly fading as it breaks down and the patina forms through it (Figure 2). Another approach to graffiti is simply to high pressure water blast it off. The localised area will over a period of time redevelop its patina to match the colour of the surrounding steel.

Figure 2: Graffiti, July 2006 (left) and August 2008 (right)
