# STRUCTURAL STEEL'S SEAMLESS AESTHETIC

Ask the project team what the key challenge was in delivering the atrium structure for NZ Blood's head office and a common theme emerges: working within an occupied building.

The atrium is the centrepiece of NZ Blood's new headquarters and part of a five-year project to consolidate the organisation's core operations under one roof.

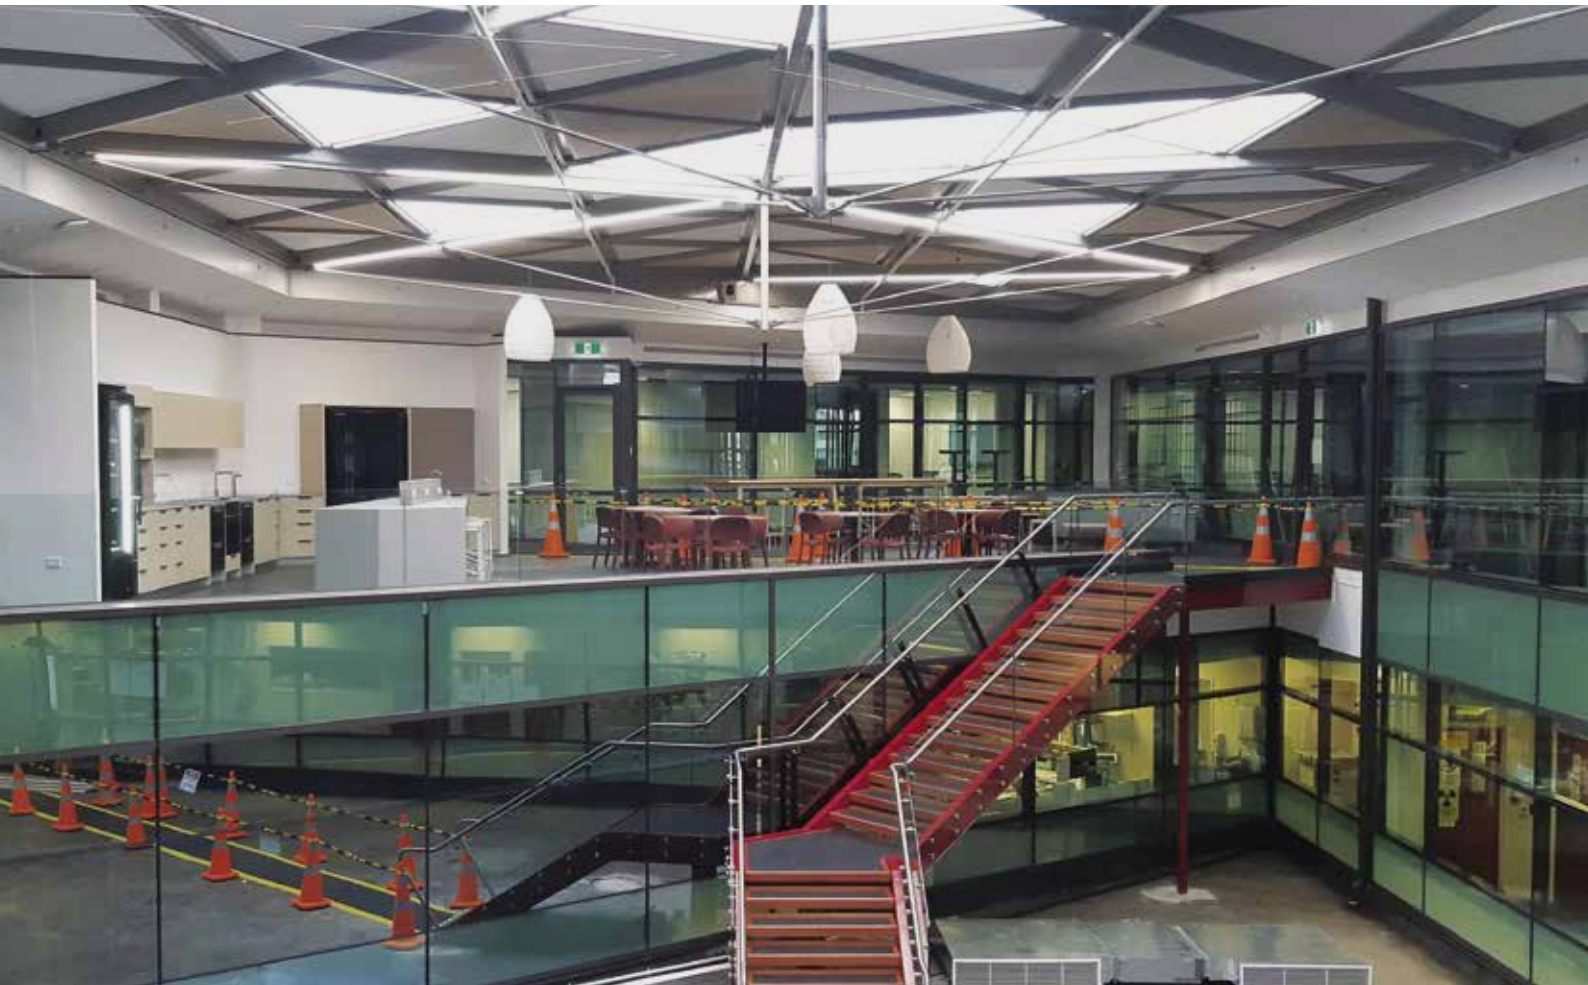
Most strikingly, perhaps, is the seamless aesthetic on show inside the atrium. Looking up from ground level, the view is of an intricate latticework of steel triangles. Connections for the architecturally exposed structural steel feature hidden bolts so that all the joints appear slick. A portion of the services are fed through the interior of the rectangular hollow section members to contribute to the clean aesthetic.

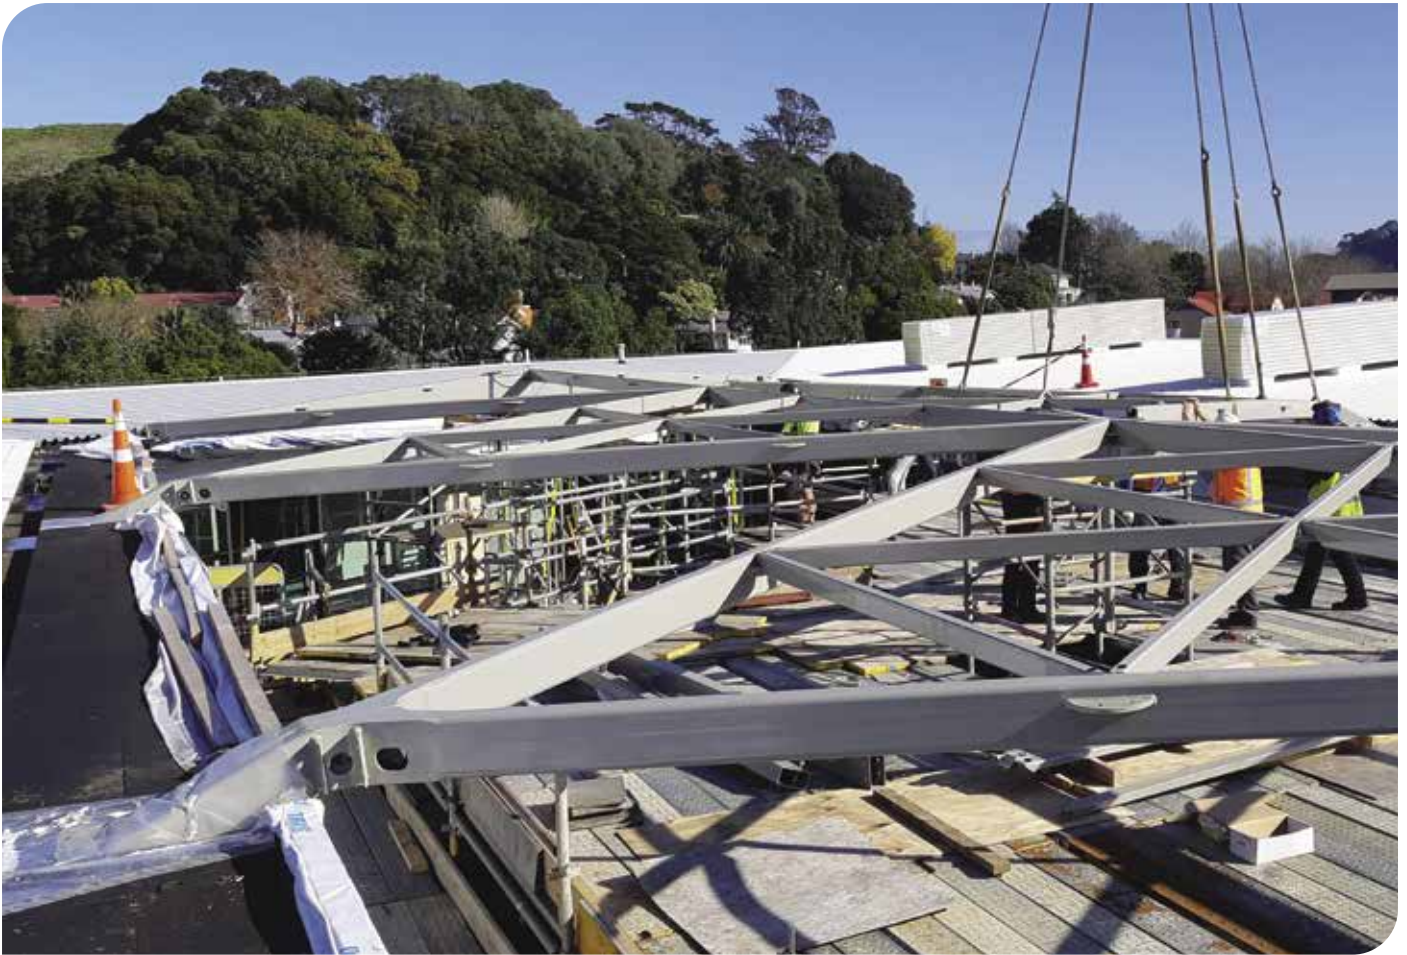
- 24 tonnes, design mass of main structure
- 1,500 pieces of steel
- 13 major assemblies
- 443kg, the heaviest single atrium assembly
- 2 tonnes of strengthening steel around perimeter
- 517kg, heaviest strengthening beam manhandled into place
- 130 tonne mobile crane

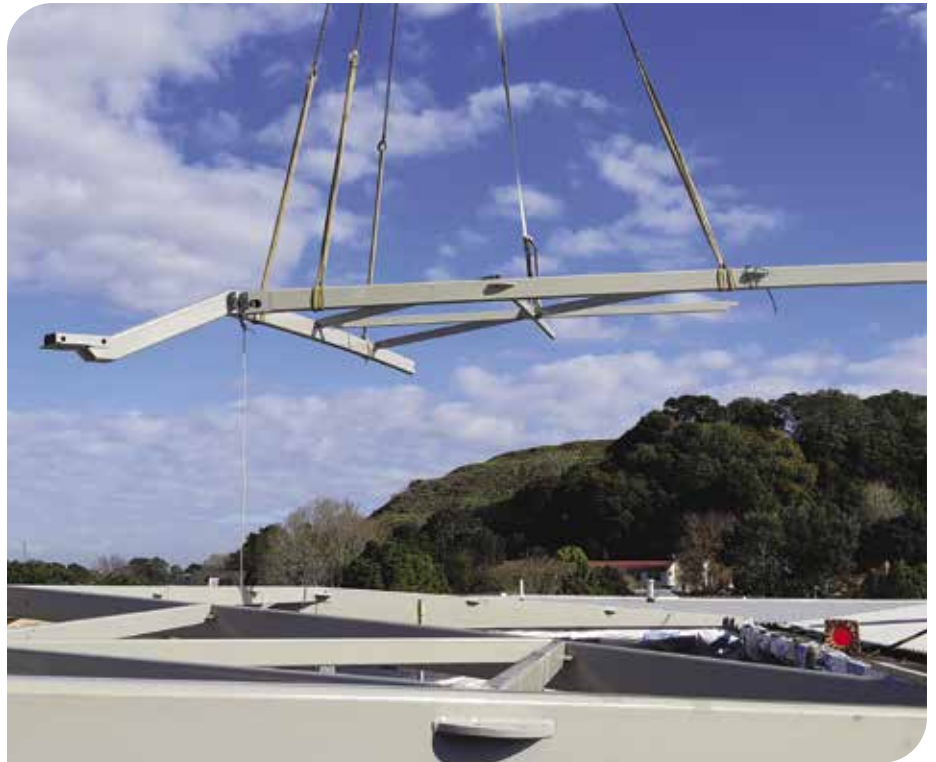
**Accessing the site was a challenge. A mobile crane was used to lift framing and other materials into the work site.**

Accessing the site was a challenge. The build team couldn't just walk in materials off the street. To get to the atrium it had to go down through the basement, up the back stairs and follow a maze of accessways. Builder Q Interiors likens it to an island at the centre of the building and getting materials to the island was hard.

The team brought some things in through the bottom and up, a scaffold was constructed on the outside of the building so other materials could go up and over, and a mobile crane was used to lift framing and plasterboard into the work site.

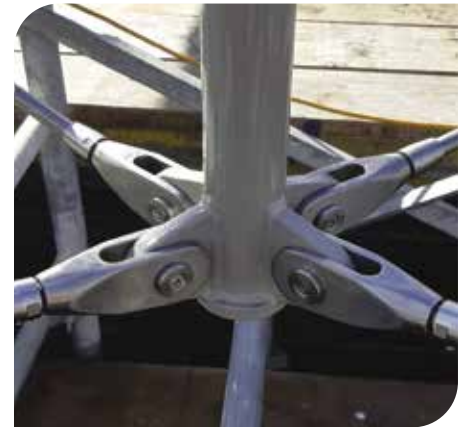
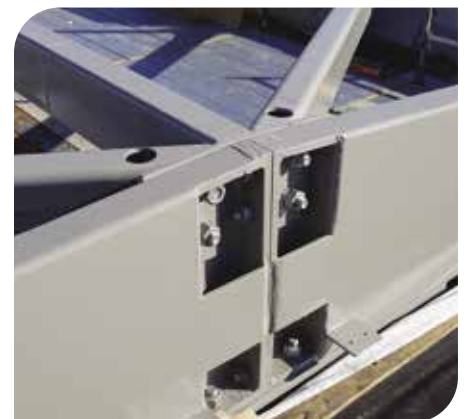
**The complex, close-tolerance connections were tricky to fabricate and required delicate and careful on-site assembly.**

The complex and close-tolerance connections were tricky to fabricate and required delicate and careful on-site assembly, all while working on the suspended birdcage outside the crane’s line of sight. Radio contact between the steel erection team and the crane operator was crucial for the delicate operation. Success came down to the steelwork being well made in the workshop so that it fitted perfectly on site.

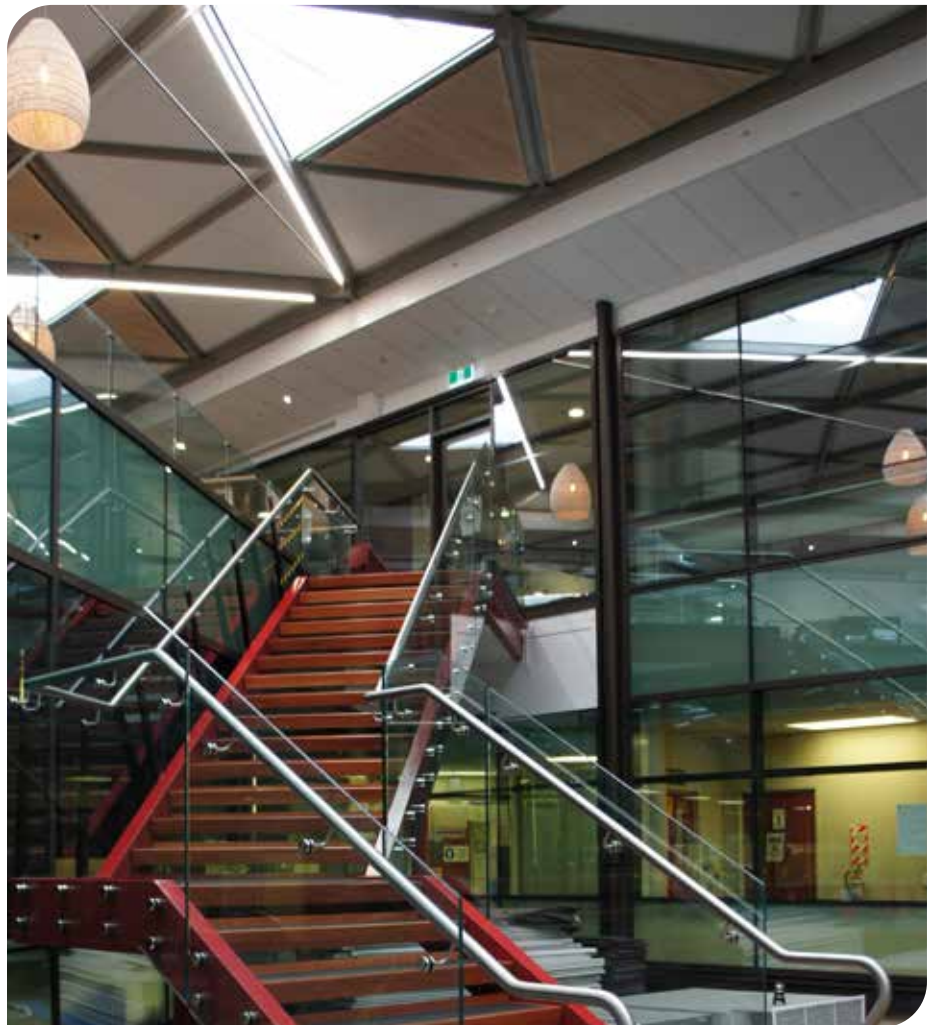
Looking up from ground level, the view is of an intricate latticework of steel triangles. Together, the triangles support each other so one can’t be removed without destabilising the whole structure.

The steel frame of small triangle shapes fitted together in a particular order and each triangle was as important as the next. Together, they support each other so one can’t be removed without destabilising the whole structure. The team couldn’t deviate from the installation sequence. The frame was built first, followed by the roof, and installation of the sprinklers, lights and windows that hung off it.
