NEW INSIGHTS INTO STEEL BUILDING PERFORMANCE FROM THE CHRISTCHURCH NATURAL LABORATORY

G. C. Clifton¹ and G. A. MacRae²

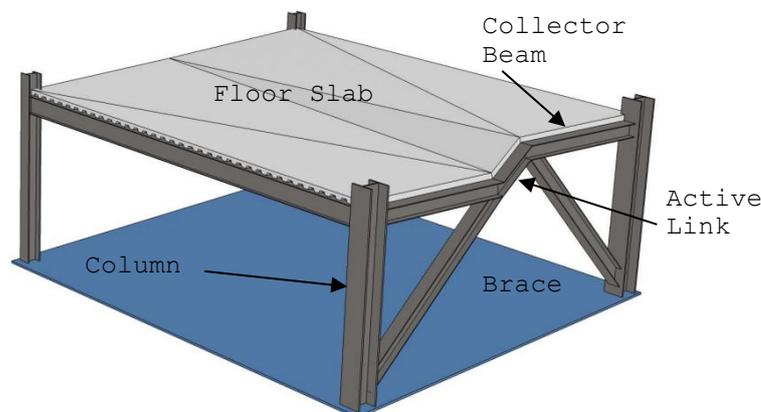
Figure 3 Floor slab contribution to EBF strength and stiffness

When the EBF system deforms inelastically it pushes the floor slab out of plane, as shown in Figure 3. A composite floor system comprising concrete slab on steel deck on composite steel beams has a high out of plane resistance to this movement. This has been quantified through research into this system's performance in fire (G.C. Clifton, Gillies, & Mago, 2010). Not only was the HSBC building stiffer than expected (see section 4.1) but it had a post-earthquake residual drift of only 0.14%. This led to consideration that the out of plane resistance of the floor slab might be a significant source of this stiffness and unexpected ability to self-centre. An undergraduate study in 2011 (Mathieson, 2011; Volynkin, 2011) provided an initial quantification of these effects, based on simple yieldline theory, and showed that the floor slab decreased the peak lateral deflection of a hypothetical, 10 storey V-braced EBF designed to current New Zealand design practice (Feeney & Clifton, 2001; NZS3404, 1997/2001/2007) under a range of 10 representative earthquake records scaled to the ULS level by between 10 and 50% and the peak residual drift to less than 33% of that without the slab effect.

The significance of the floor slab to the strength and stiffness of EBFs is greater than that found from previous researchers, such as (Riccles & Popov, 1987), who concluded the contribution of the slab was an increase in the shear resistance of 8-12% of the shear capacity of the active link alone. However, the contribution of the slab may degrade over successive cycles of inelastic loading if pushed into the inelastic range and this is a key aspect for further research. In a study on the effect of a floor slab on the strength and stiffness of a stepping base concentrically braced frame (CBF) system, Wijanto (Wijanto, 2010) determined that the inclusion of the floor slab out of plane properties increased the stiffness by a factor of 2 compared with modelling just as an in-plane diaphragm.

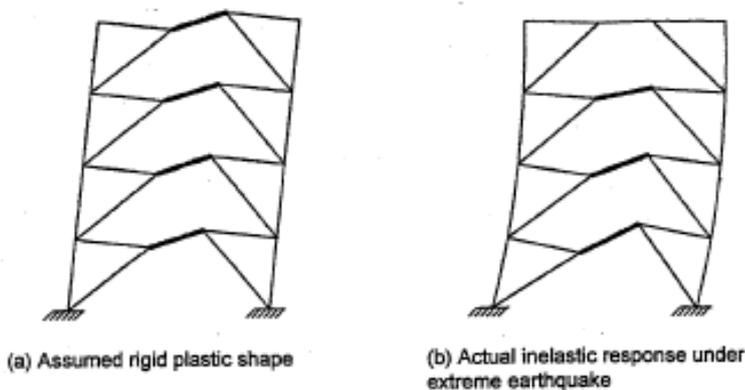
Figure 5 EBF plastic collapse mechanisms

The capacity design procedure for steel seismic-resisting systems is based on the structure being displaced laterally so that yielding hinges form in all the primary seismic resisting system elements to give a yielding mechanism (NZS3404, 1997/2001/2007). For eccentrically braced frames, the yielding mechanism means the EBF forms a plastic collapse mechanism, with yielding in each active link and in theory at the column bases, if these are sufficiently rigid (more on this in section 4.6). The assumed plastic collapse mechanism is shown in Figure 5

This plastic collapse mechanism assumes uniform inelastic demand in each active link, meaning that the collector beams at a given level and the braces framing up into that level are designed for the overstrength actions from the brace. The columns are designed for the cumulative overstrength actions at and above the storey under consideration.

In the 22 February 2011 earthquake, with no exceptions, inelastic action was confined to the active links in those two buildings. In HSBC Tower, the demand was similar up all levels, meaning the inelastic shape approximated that in Figure 5 (a), while with Pacific Tower, inelastic demand concentrated into the lower 8 storeys of the building, due significantly to the non-structural contribution of the numerous full height fire and acoustic rated walls in the upper 14 storeys. In all the other steel framed buildings surveyed in the Christchurch CBD, inelastic demand was limited to the primary seismic-resisting system elements, even in one 7 storey perimeter moment-resisting steel framed (PMRSF) building that was severely impacted by differential ground instability, with differential settlement of over 100mm between the central gravity system and the external PMRSFs. Given the range of buildings impacted comprised MRFs, EBFs and CBFs, ranging from 3 to 22 storeys in height and with the capacity design derived design actions governed by overstrength in some cases and upper limit actions in others, this outcome supports the adequacy of the current capacity design procedure.

Figure 5 shows the expected inelastic shape generated by a severe earthquake. As described in section 4.5, the EBF superstructures in buildings developed this shape. In theory, if the column bases are fixed, this requires column base hinging. However, in practice, none was observed in any of the steel framed buildings investigated in Christchurch and none has been reported in any multi-storey building sited on stable ground.
